Université Mohamed Khider – Biskra
Faculté des Sciences et de la technologie
Département de Génie Civil et Hydraulique
Réf :

Thèse de Doctorat LMD
Spécialité : GENIE CIVIL
Option : MATERIAUX DE CONSTRUCTION

Etude de la pathologie des fissurations de bâtiment suite au phénomène de dissolution du gypse cas des bâtiments de Ouled Djellal.

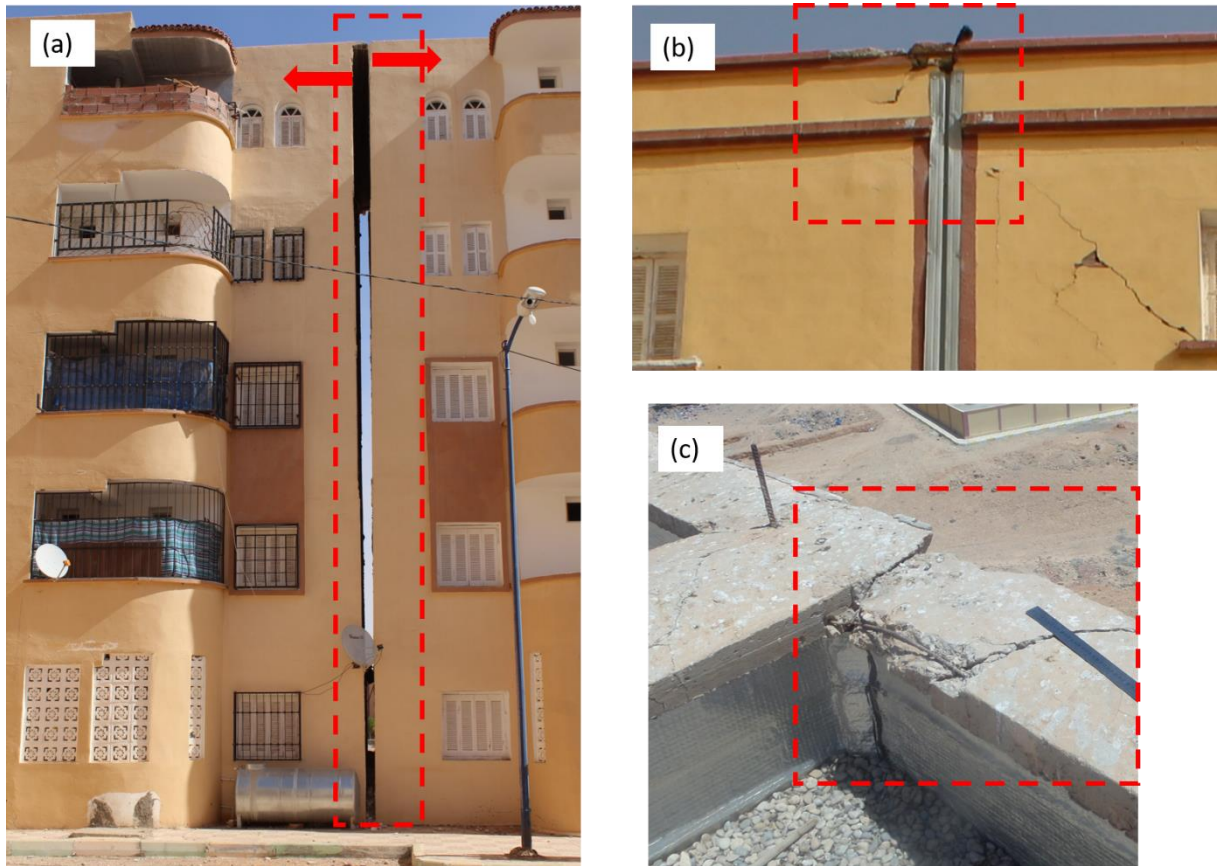
Fig. 2.3. Tilting of buildings: (a) buildings 12 and 13 of area 4. (b) and (c) buildings 4 and 5 of area 3.

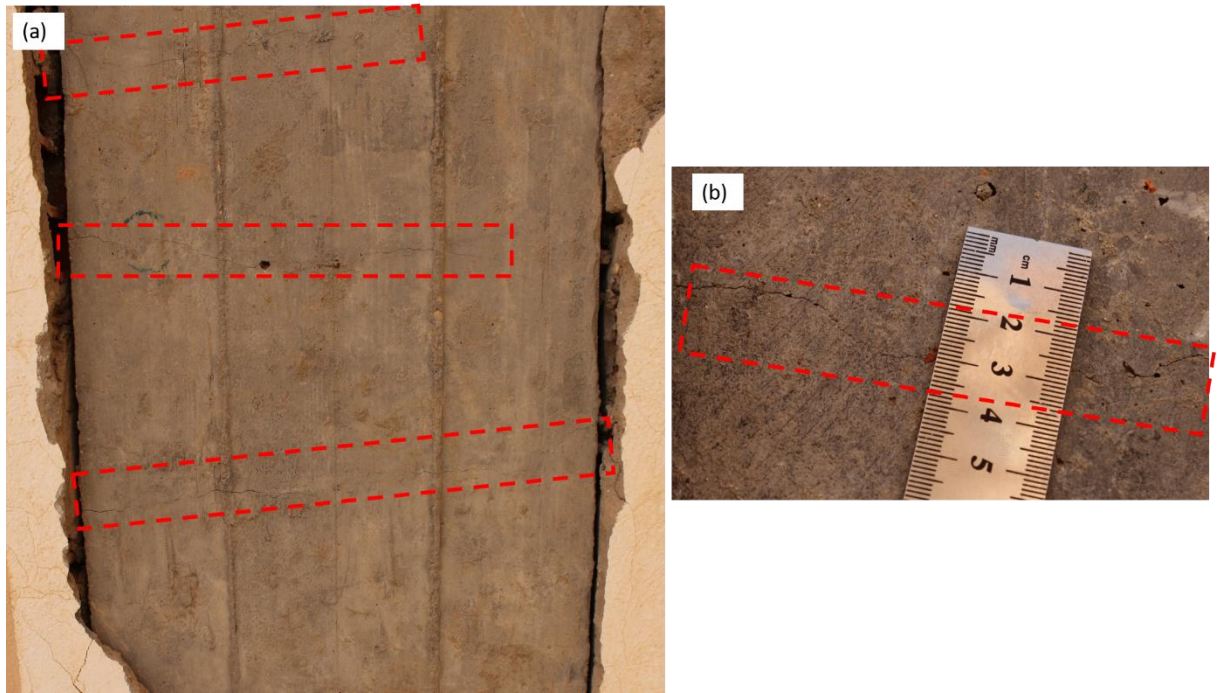
Fig. 2.4. Horizontal column cracking recorded: (a) on the building 1 of area 1 ;(b) on the building 4 of area 3.

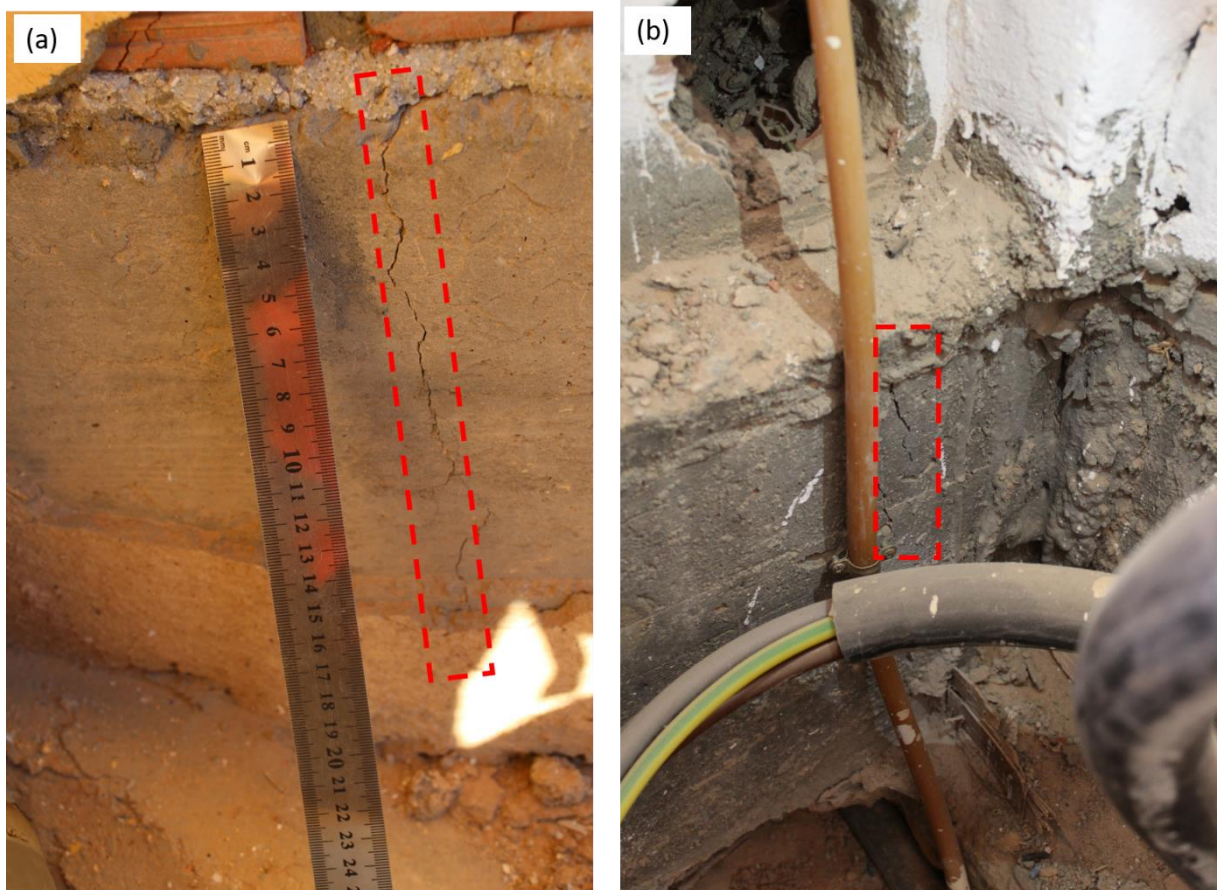
Fig. 2.5. Plinth beam cracking recorded on: (a) Exterior of the building 4 of Area 3; (b) Interior of the building 13 of Area 4.

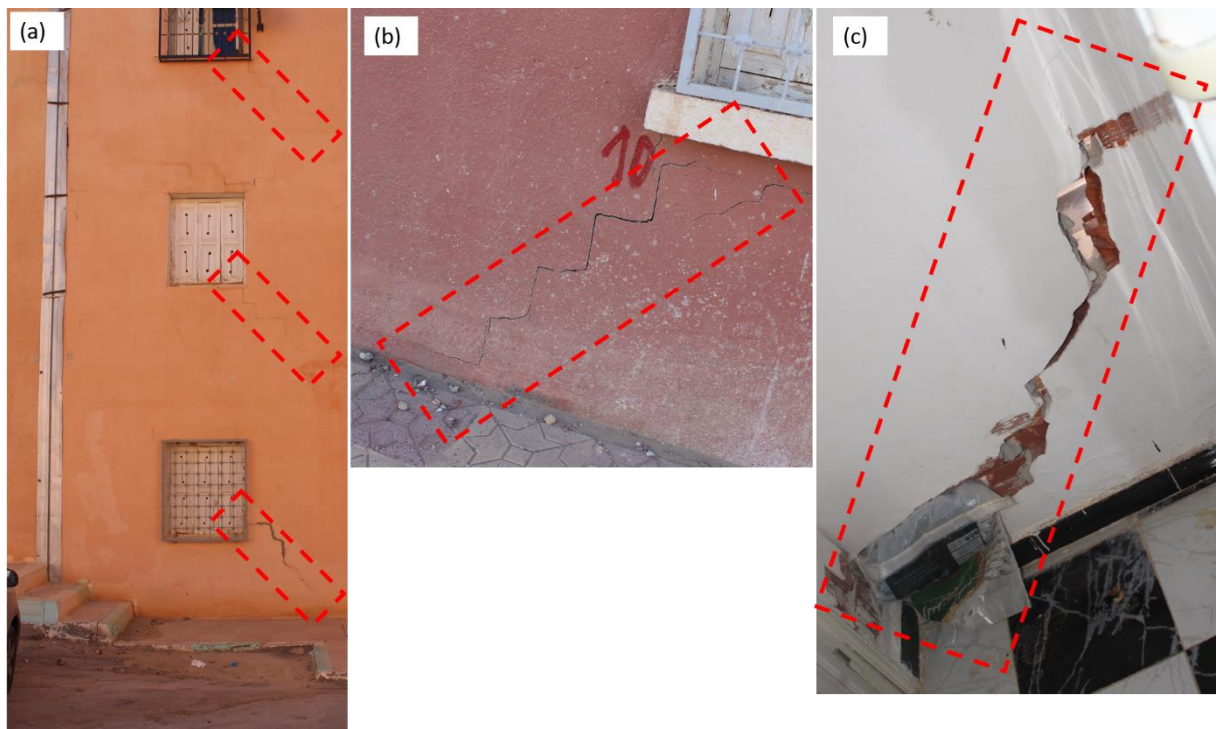
Fig. 2.6. Diagonal masonry wall cracking recorded on: (a) Building 5 of Area 1; (b) Building 8 of Area 1, (c) Interior of the building 4 of Area 3.

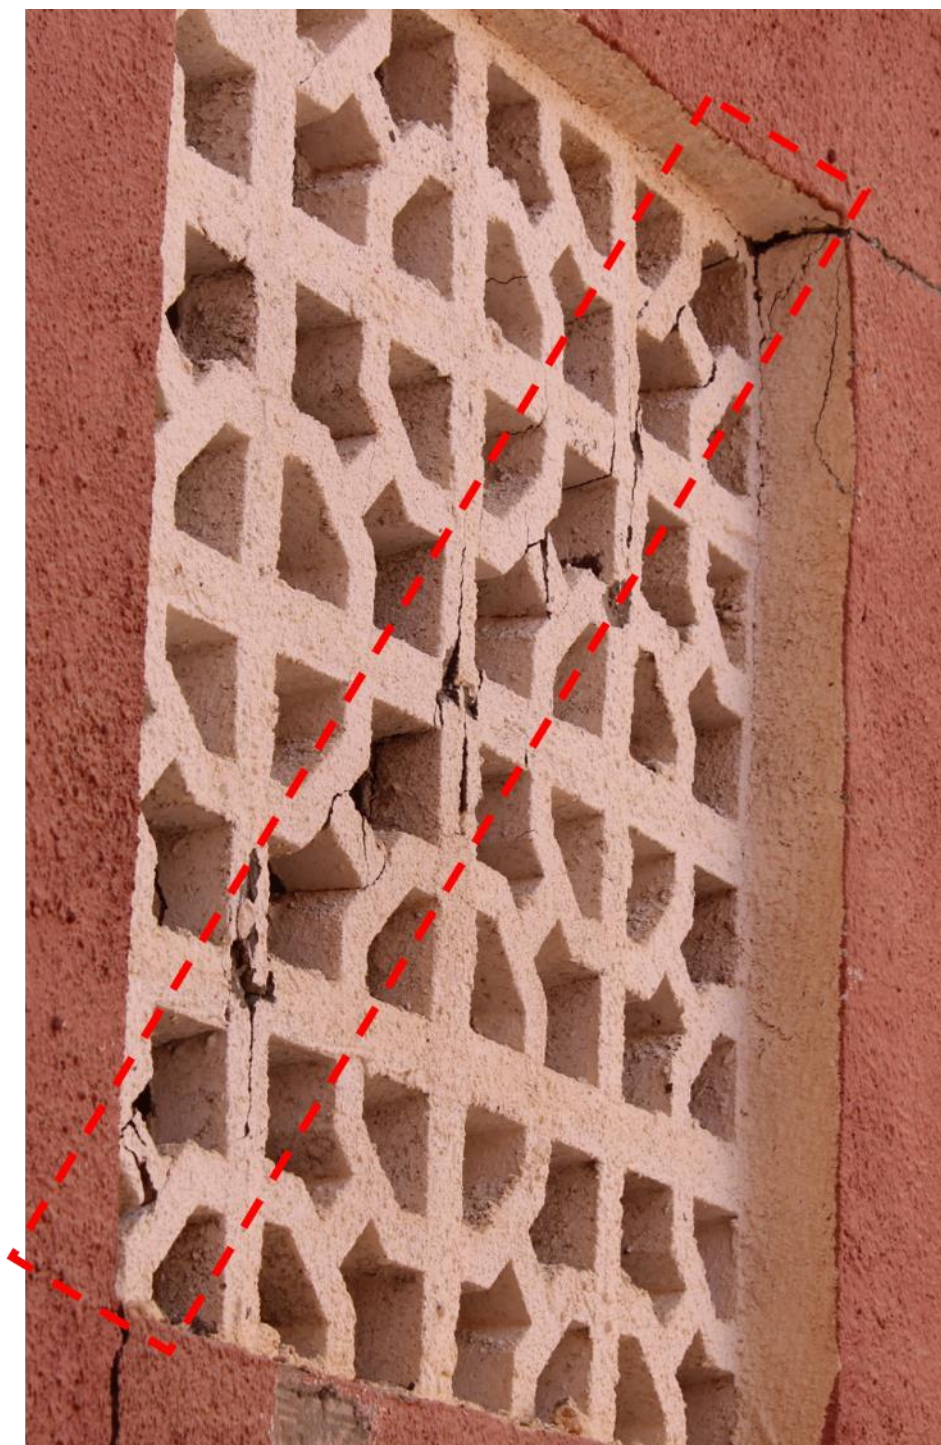
Fig. 2.7. Diagonal decorative perforated concrete panel cracking recorded on building 8 of Area 1.

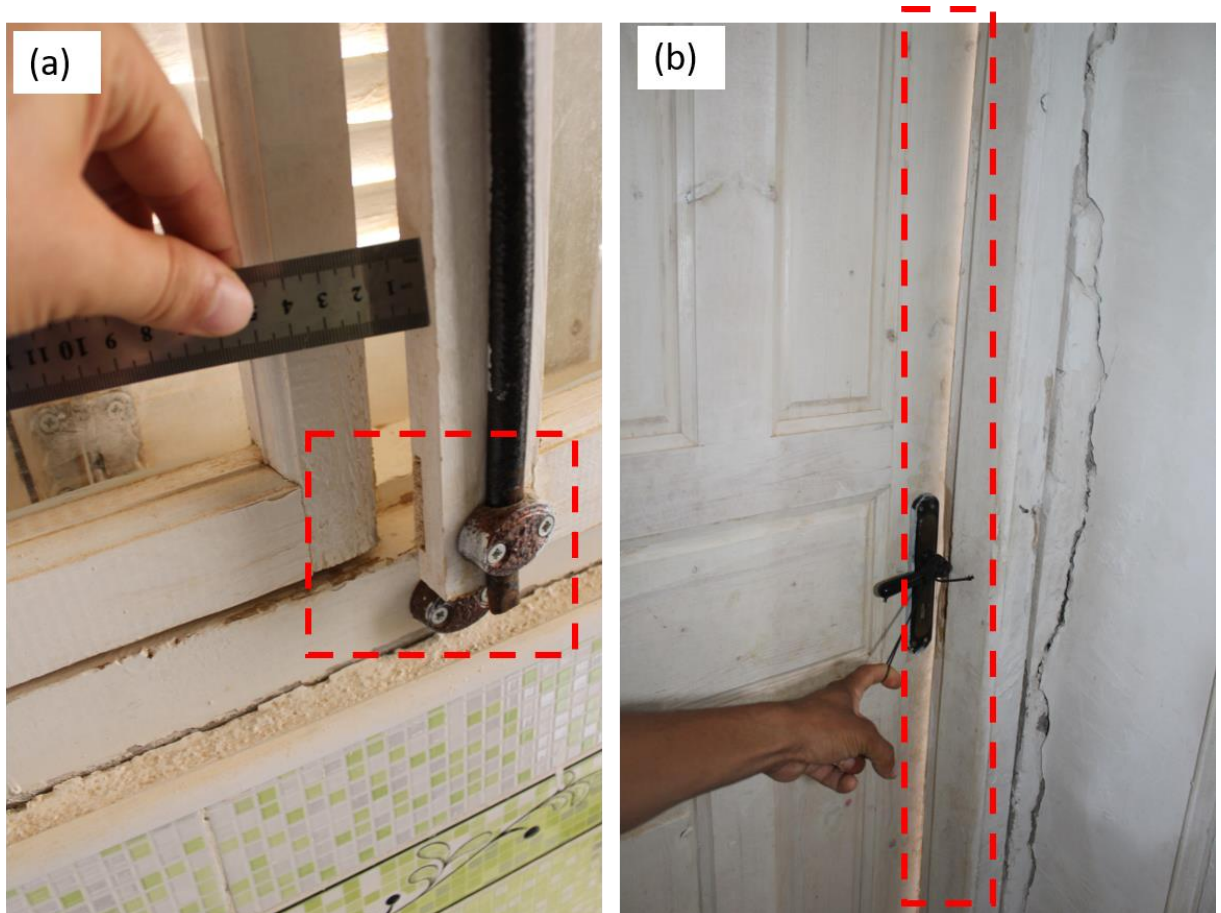
Fig. 2.8. (a) Sticking of window at building 8 of Area 1; (b) Sticking of door at building 4 of Area 3.

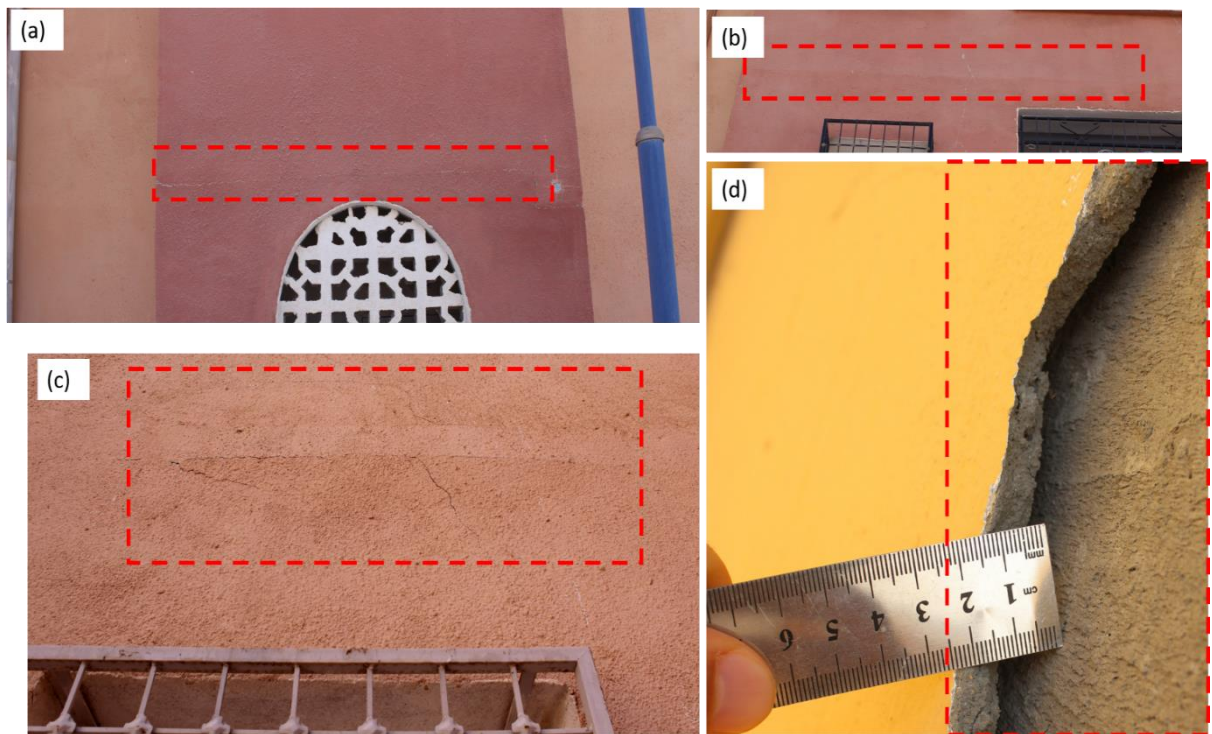
Fig. 2.9. Decollement of the exterior cladding that covers the structure elements recorded on the buildings: (a), (b) 8 of area 1; (c) 4 of area 1; (d) 4 of area 3.

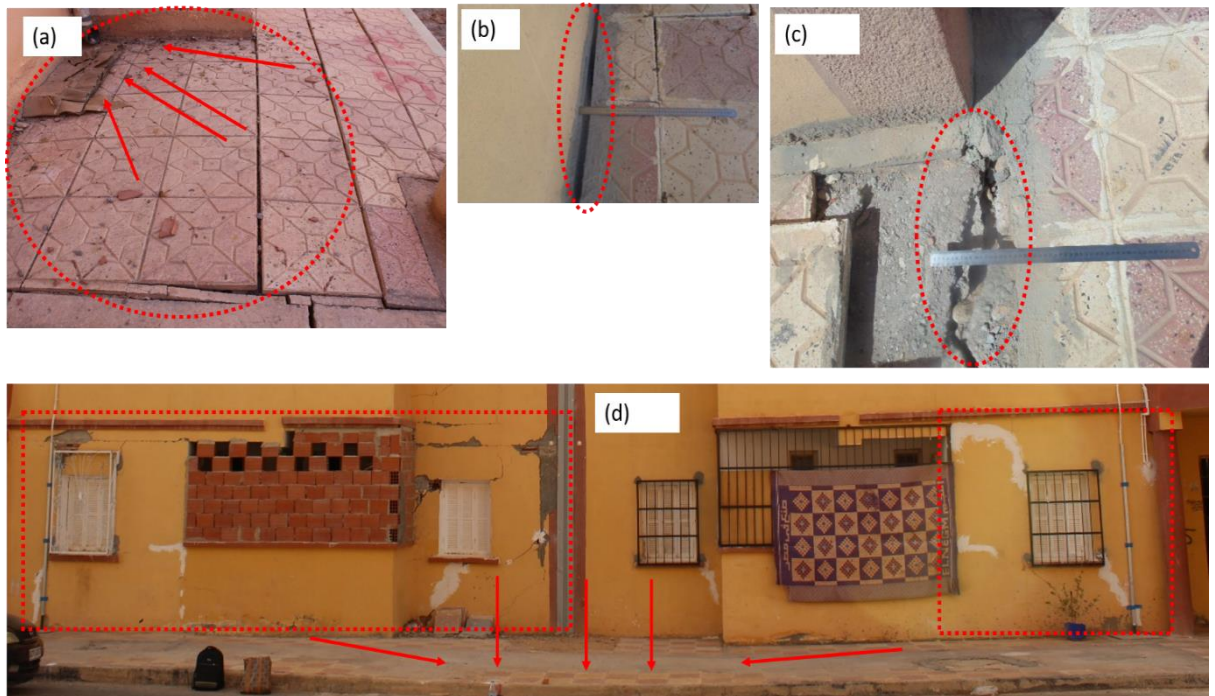
Fig. 2.11. Signs of settlement in the building foundations and subsidence: (a) Settlement in the foundation and cracking of the surrounding pavement, (b) Voids between the building and its pavement that are supposed to be associated with ground sliding resulting from the excessive settlement of adjacent foundation, (c) Significant cracking that crosses the tile layer until the soil (d) Subsidence parallel to intensive cracks on the building facade.

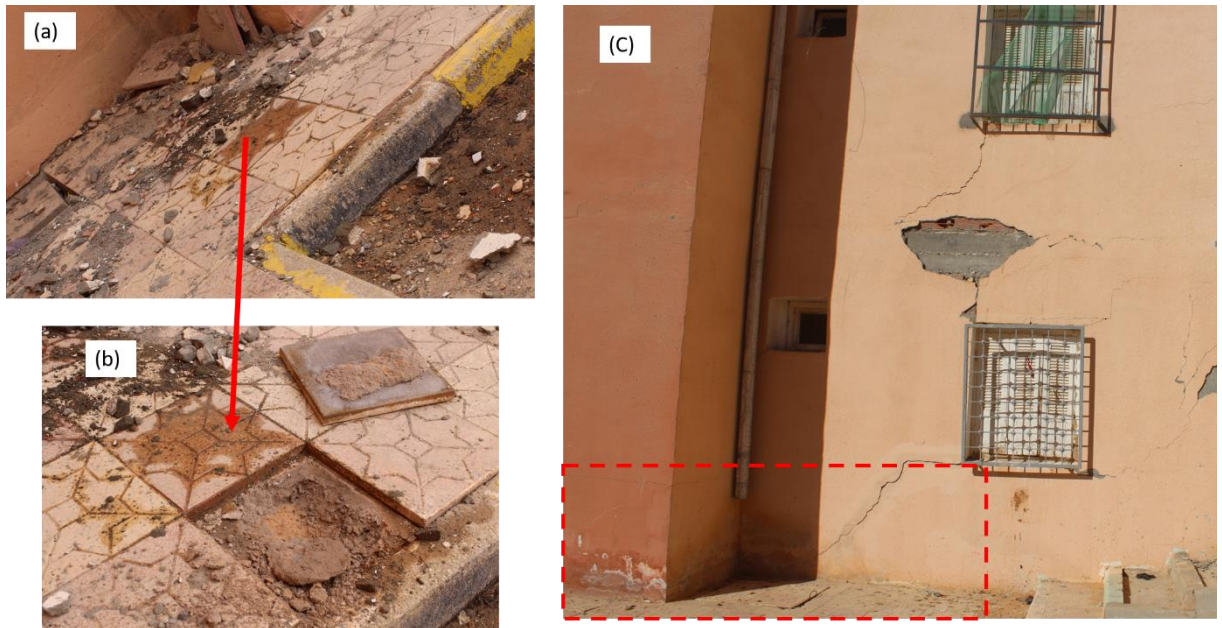
Fig. 2.12. Presence of water infiltrations signs: (a) High humidification of the pavements and its base adjacent to the affected building 6 from area 1. (b) Traces of high previous humidification on the bottom of the wall of the affected building 1 from area 1 that align with very obvious cracking of the same wall.

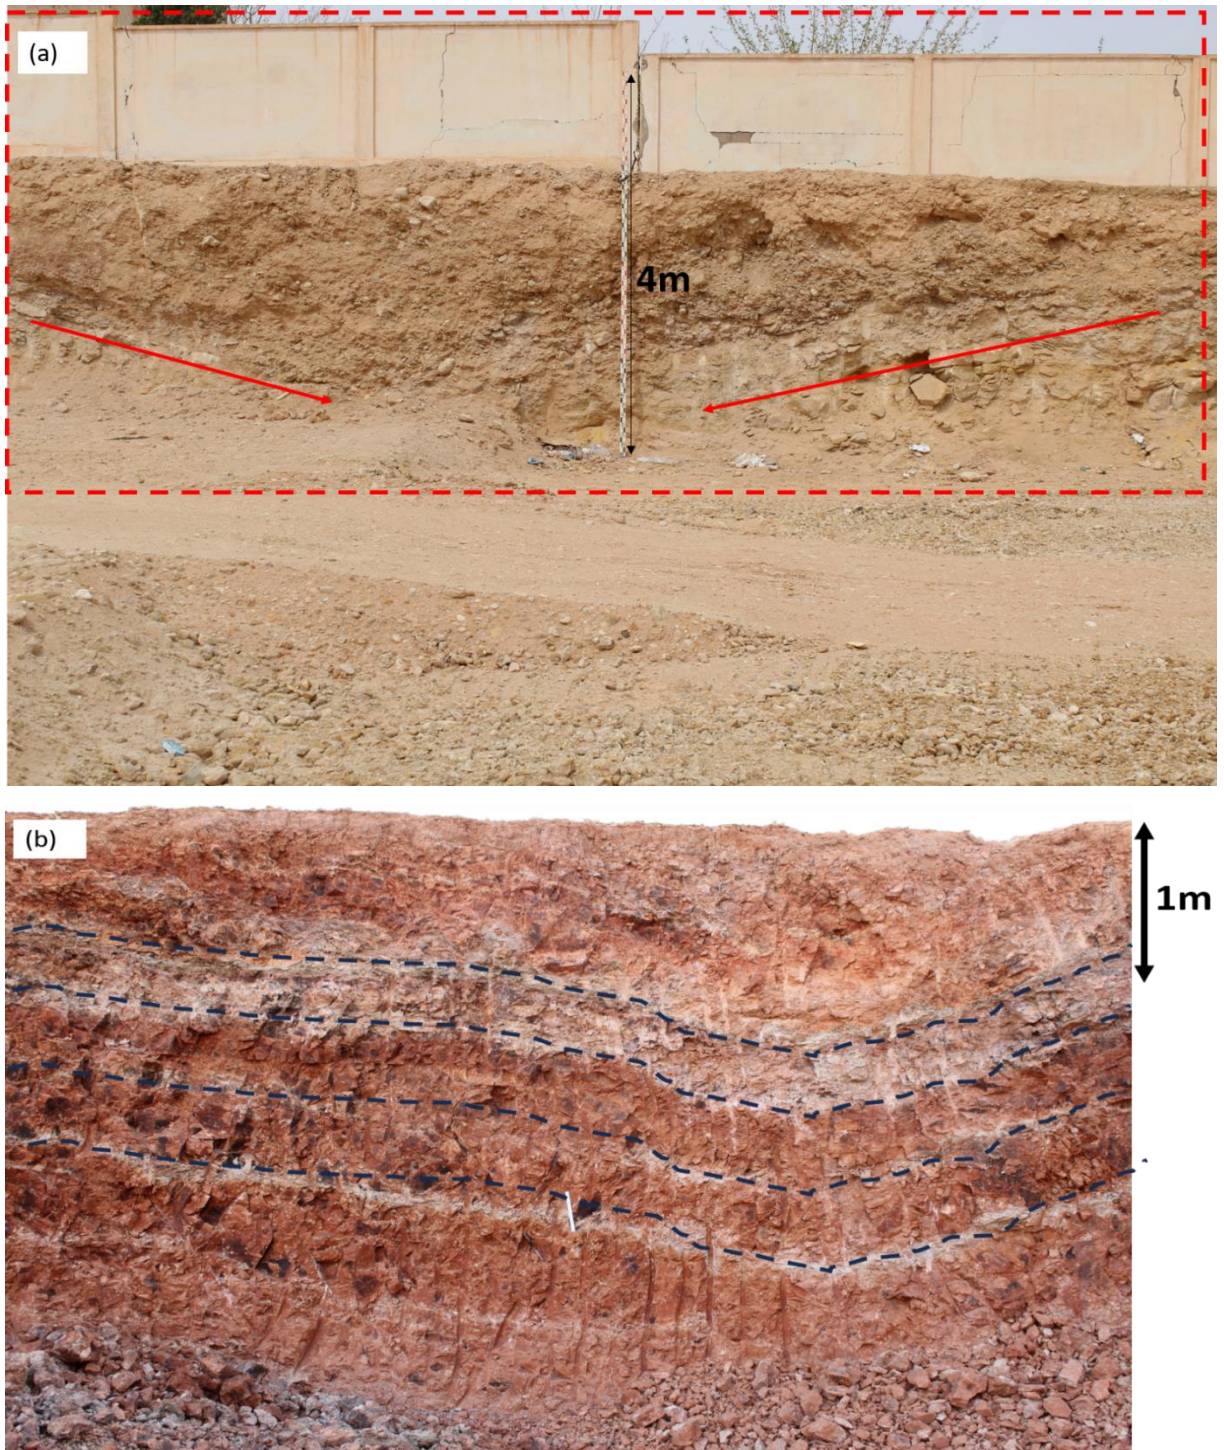
Fig. 2.14. Geomorphological evidence in the form of previous cover sagging sinkholes: (a) Parallel to the masonry fence of the National Institute of Vocational Training in the study area; (b) Within a proximity of less than 1,8 kilometers from the affected buildings.

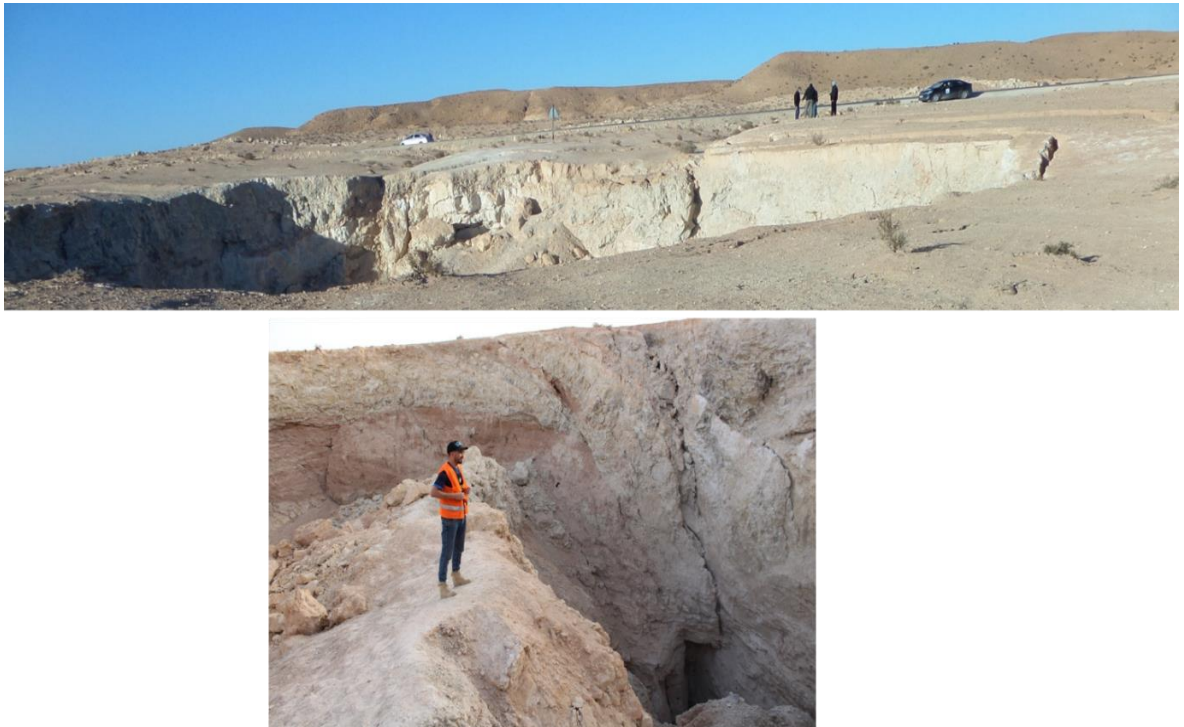
Fig. 2.16. Collapse sinkhole that occurs in 2020, approximately 22 kilometers south of the study area.

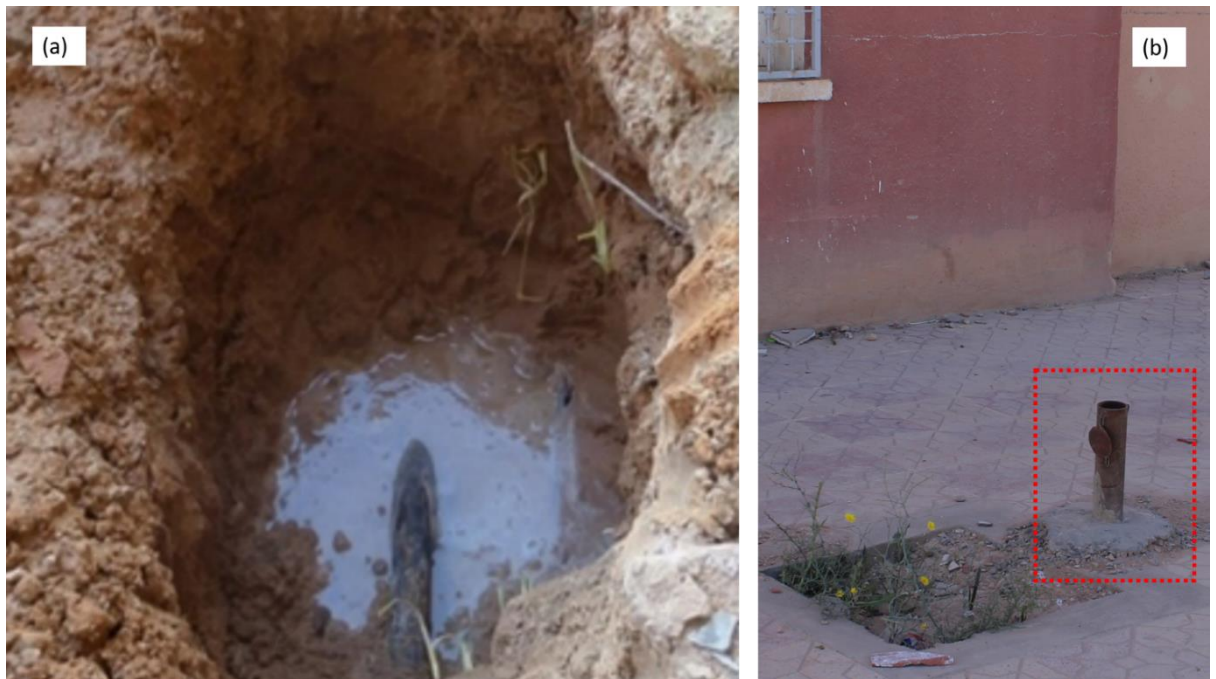
Fig. 3.11. (a): An instance of leakage was identified in front of the impacted building 1.

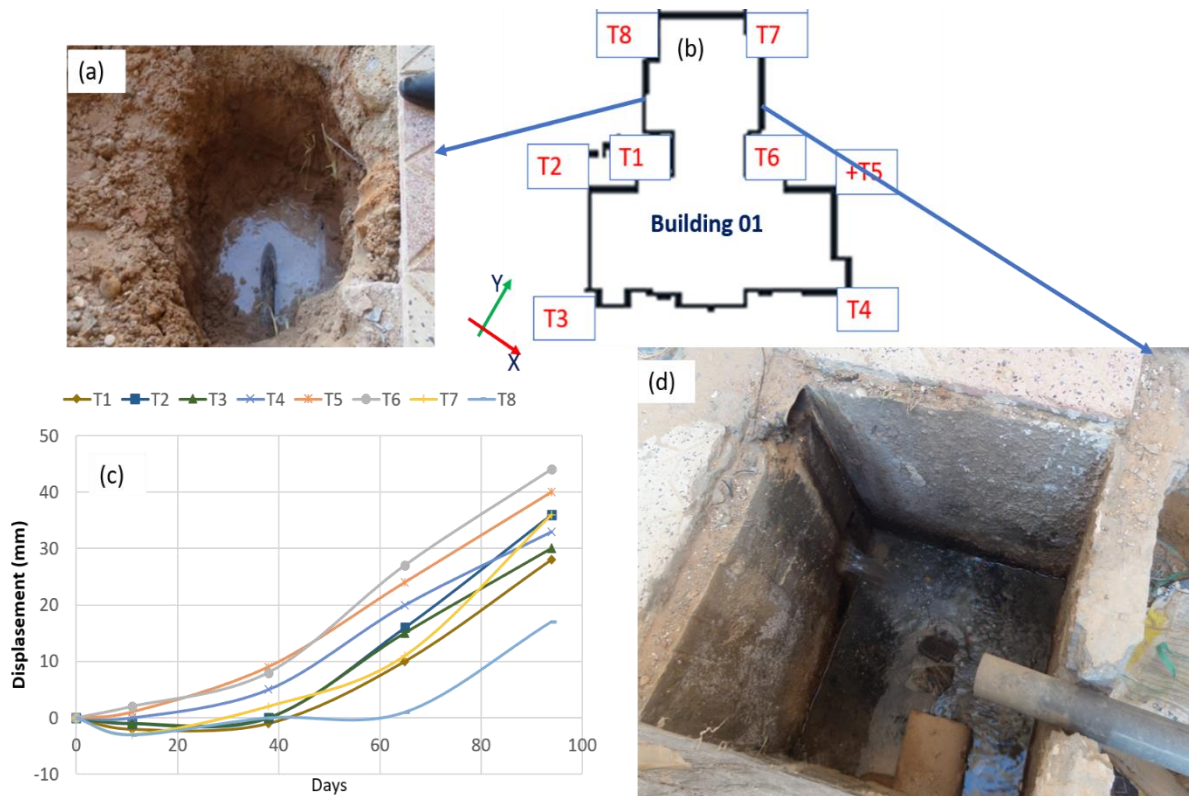
Fig. 3.21. Building 1: (a) Water Pipeline Leakage Adjacent to the Building, (b) Target References on the Building, (c) Target Movements Versus Time (Days), (d) Wastewater and Sewage Pipes Beneath the Block Infrastructure.

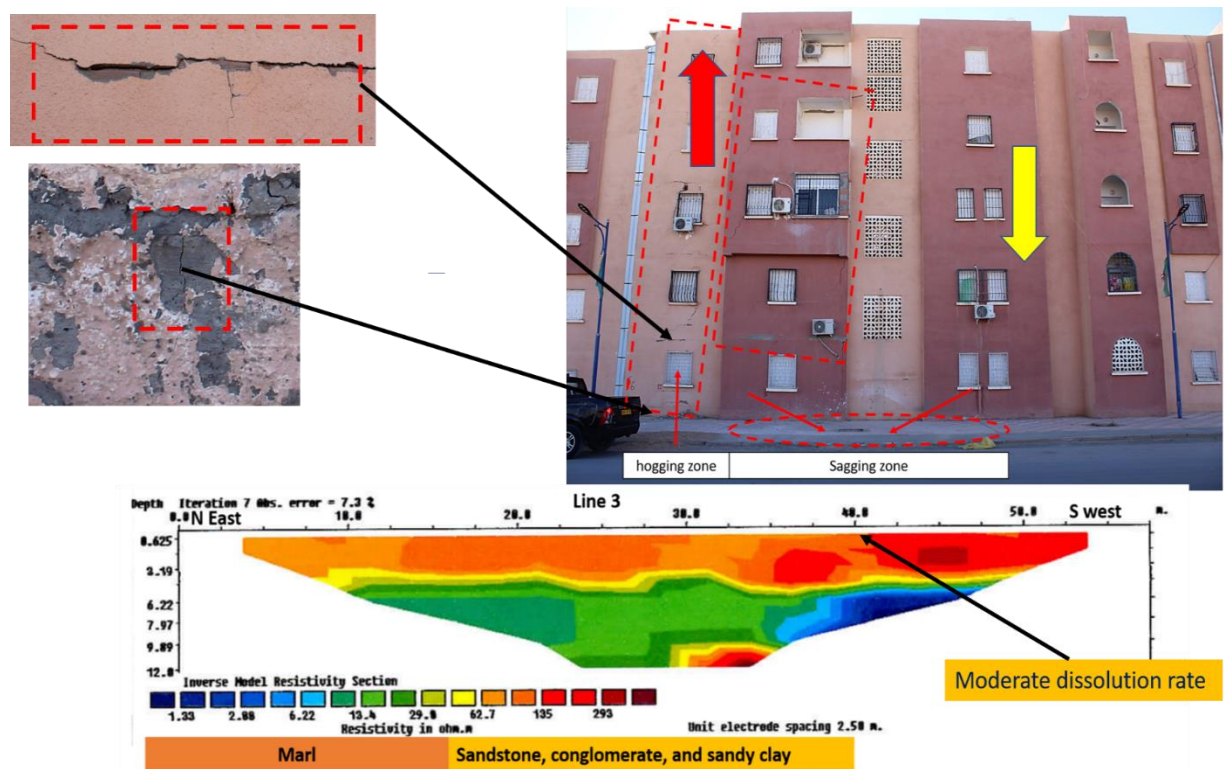
Fig. 3.29. Failure analysis of block 8.

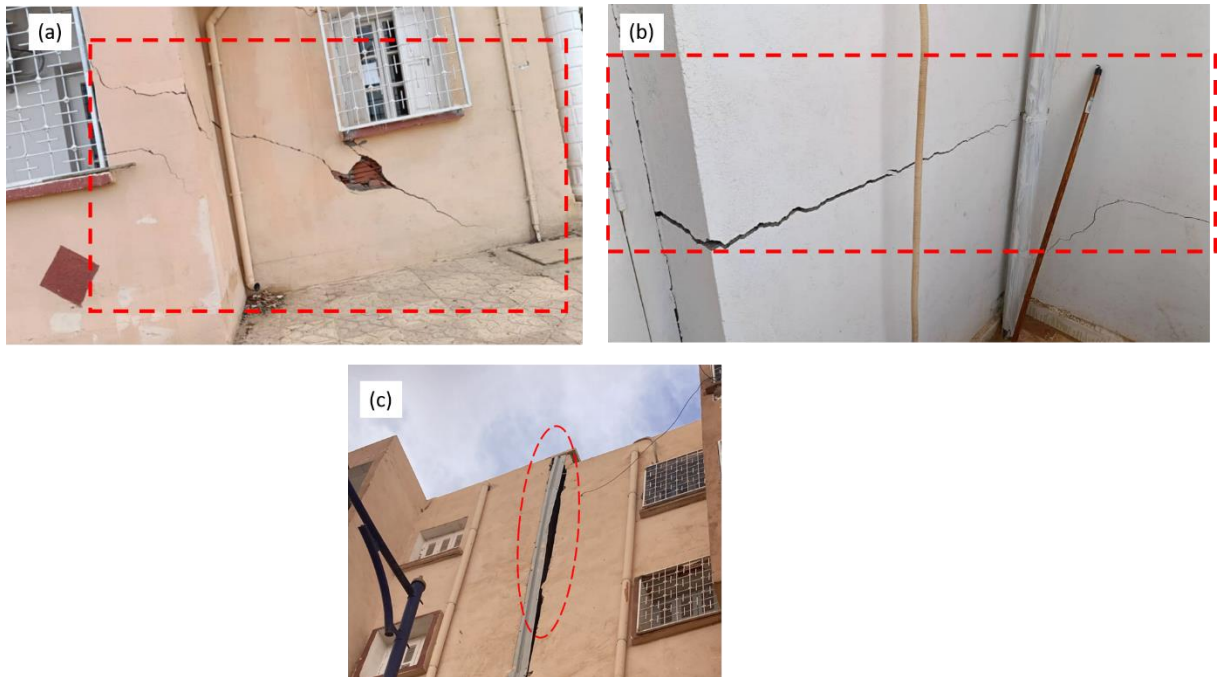
Fig. 4.2. Newly observed defects in Area 4: (a) Exterior masonry cracking of building 4, (b) Interior masonry cracking of building 4, (c) Divergence at the dilatation joint between buildings 4 and 5.

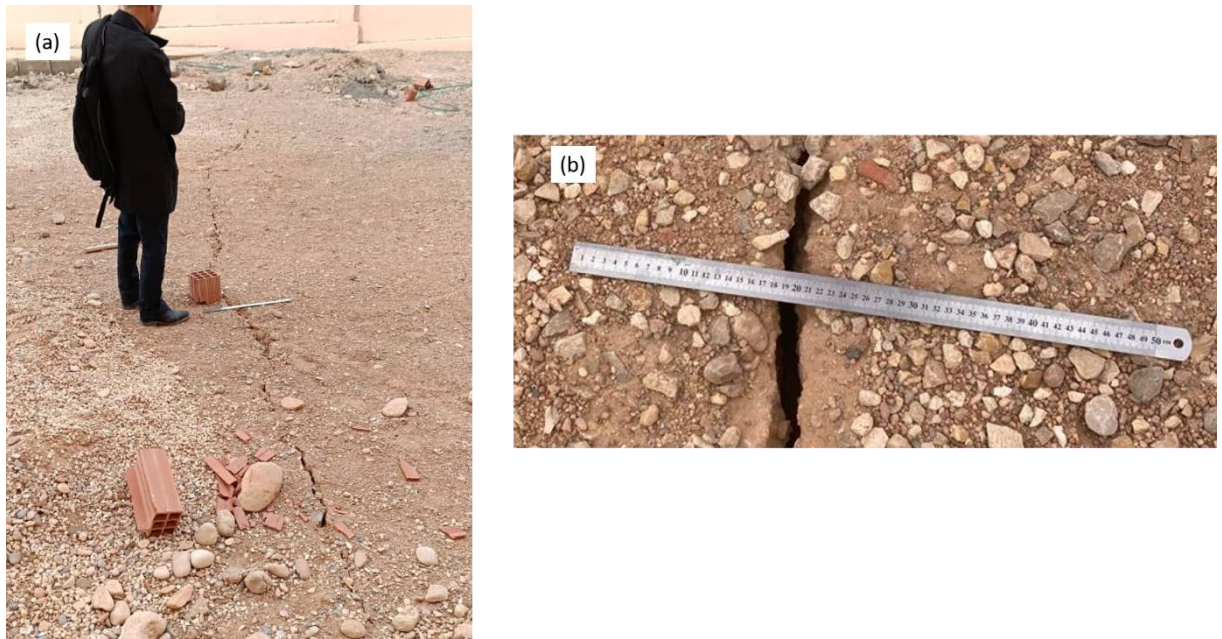
Fig. 4.3. Ground cracking signs reaching 30 mm width observed in the vicinity of buildings 4 and 5.

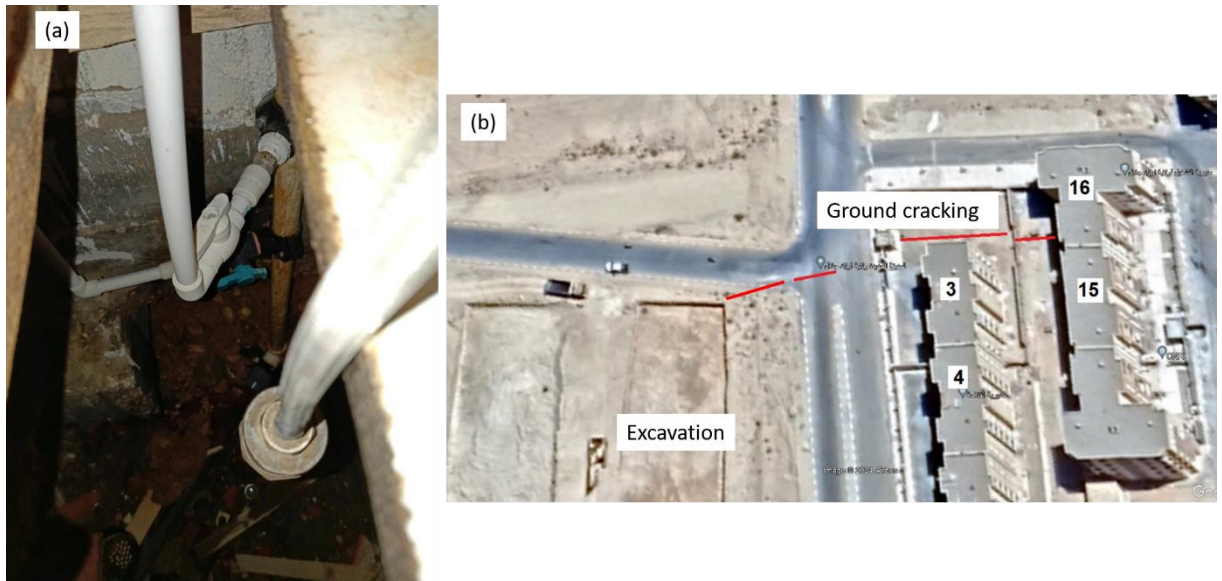
Fig. 4.4. (a) Water pipeline leaks, (b) Ground crack propagation along the red line to the excavation boundary.

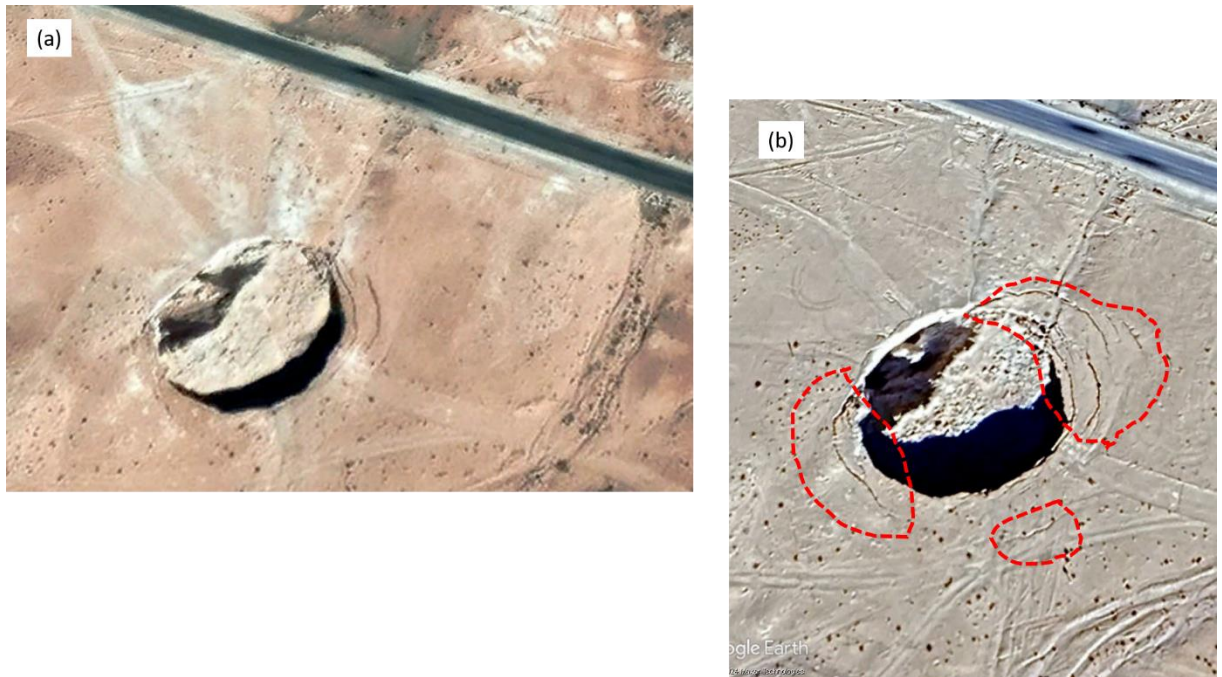
Fig. 4.5. (a),(b): Enlargement of sinkhole occurring approximately 22 kilometers south of the study area three years after 2020.
