Université Mohamed Khider – Biskra
Faculté des Sciences et de la technologie
Département de Génie Civil et Hydraulique
Réf :

Thèse de Doctorat LMD
Spécialité : GENIE CIVIL
Option : MATERIAUX DE CONSTRUCTION

Etude de la pathologie des fissurations de bâtiment suite au phénomène de dissolution du gypse cas des bâtiments de Ouled Djellal.

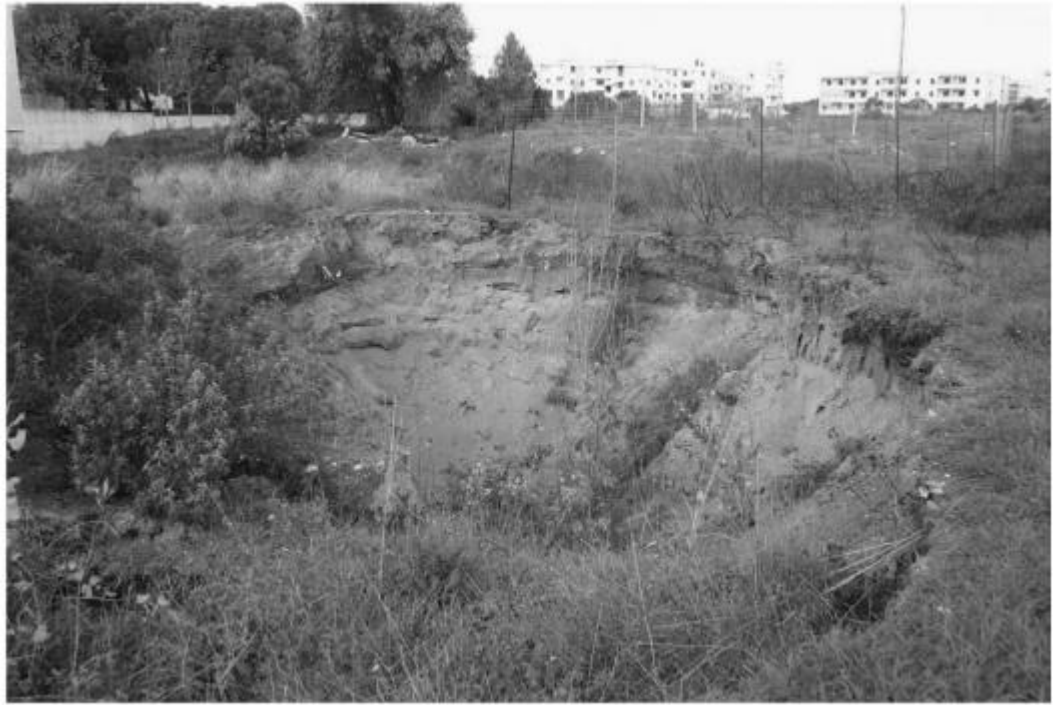
Fig. 1.3. Collapse of a sinkhole located at the western boundary of the Acquarotta Canal, with the Marina Lesina residential area (Italy) visible in the background. This image illustrates both the anthropogenic ground and the aeolian sands revealed along the steep walls of the active sinkhole [40].

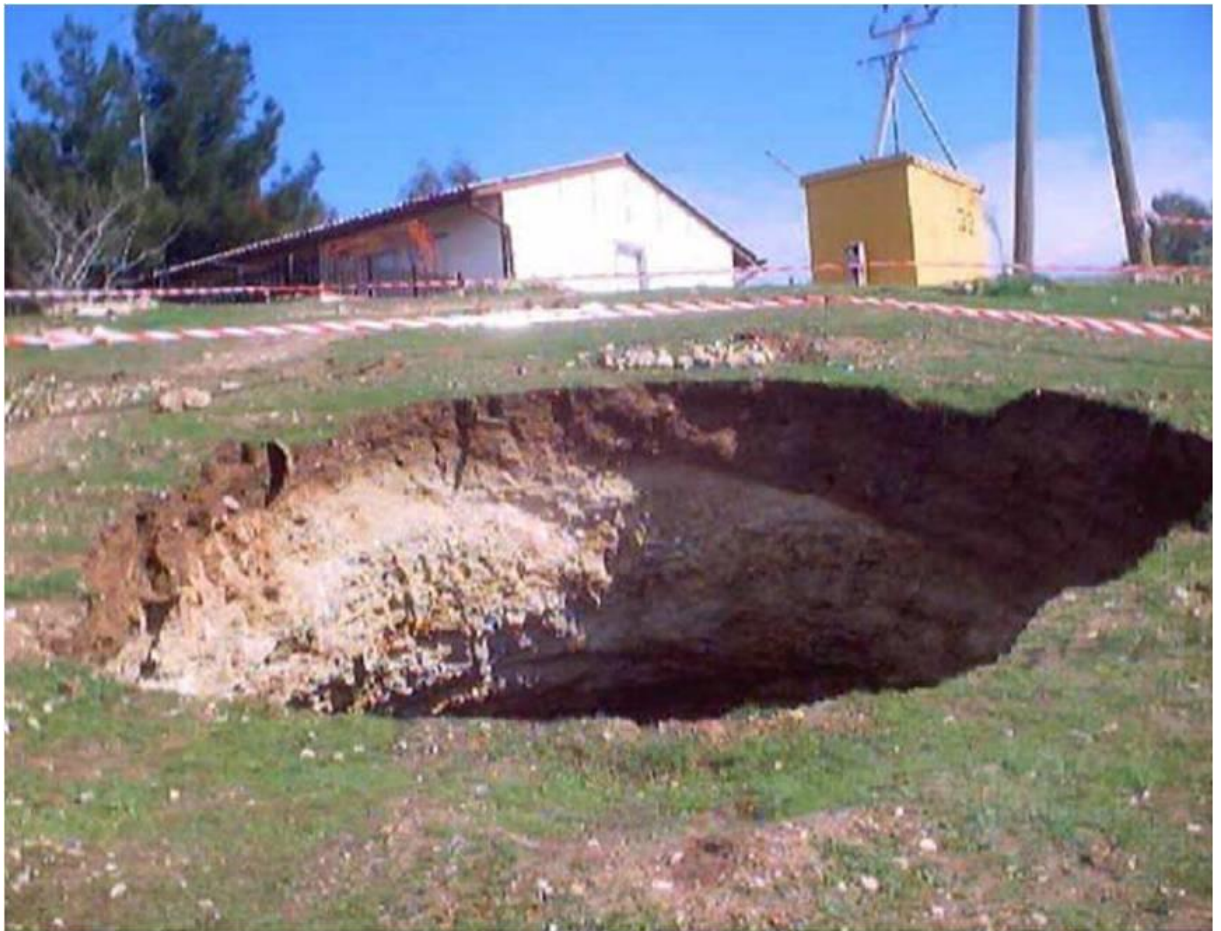
Fig. 1.4. The sinkhole collapse occurring downstream of the Mosul Dam in Iraq is linked to the dissolution of gypsum and anhydrite layers (source: U.S. Army Corps of Engineers, 2007; public domain).

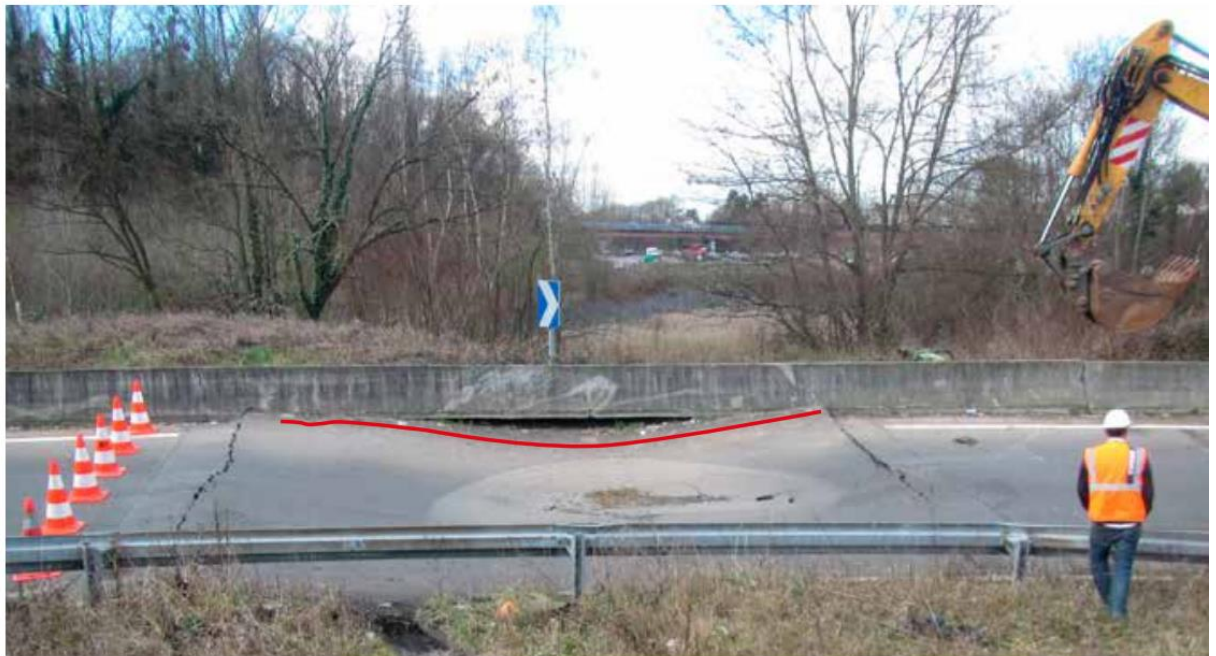
Fig. 1.5. The subsidence, measuring 8.5 m x 9.5 m, caused the flexion of the roadway (indicated in red) observed on the ramp of the A15 motorway in Franconville, Val d'Oise (95) in 2014, as reported by Cerema [12].

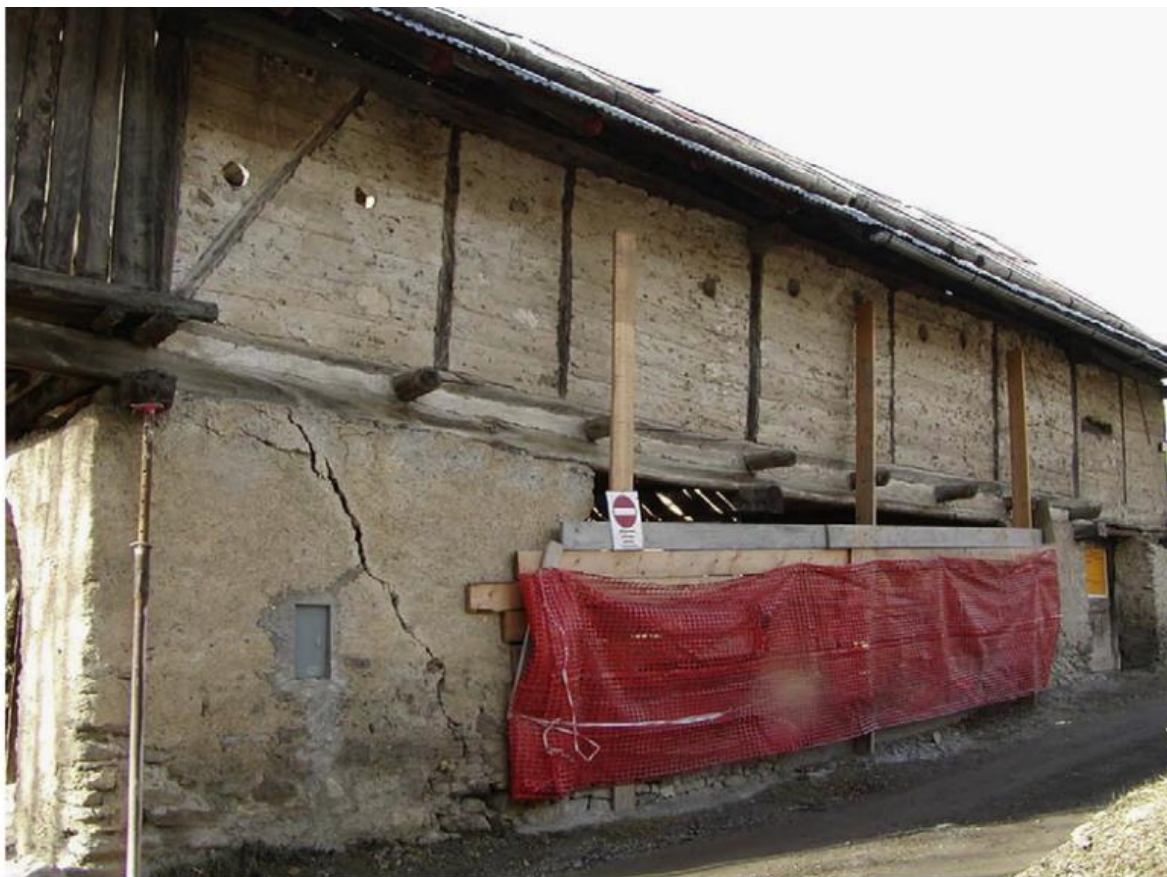
[37] emphasize through case studies in the Western Italian Alps that the impacts of deep dissolution on human activities and structures become significant when surface movement velocities are measured in centimeters per year, as these rates are incompatible with the stability of buildings and infrastructures. In certain instances, structures have suffered direct damage due to the abrupt sinking of depressions that can extend over several meters (Fig. 1.10).

Fig. 1.10. Severe damage (including open fractures and wall collapses) observed in a rural building at the Cimabosco site in the Susa Valley, Western Italian Alps [37].

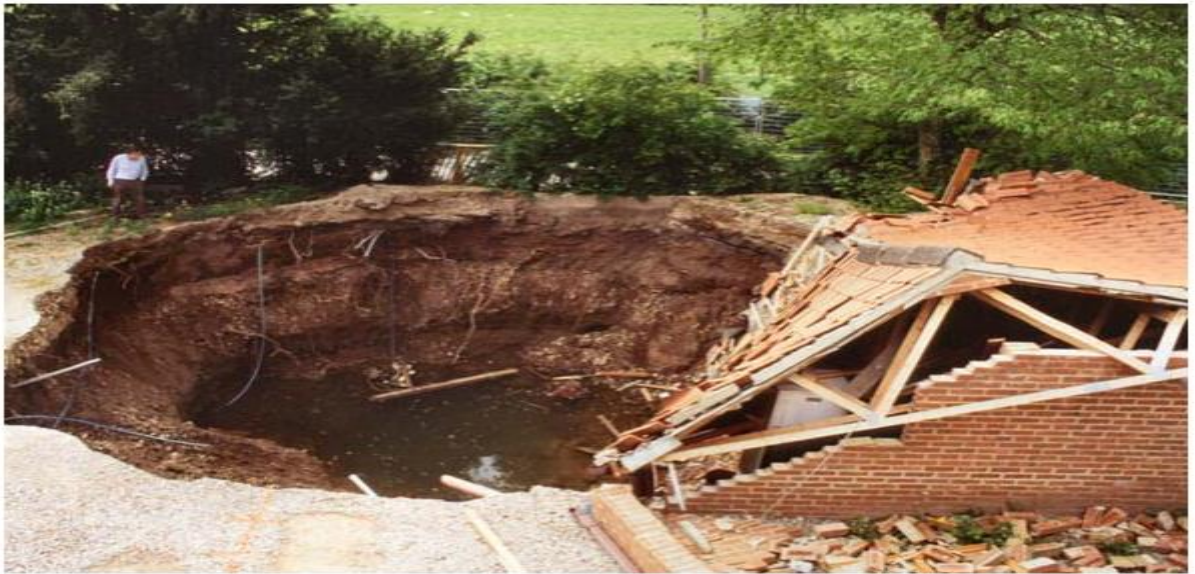
Fig. 1.11. Category 7 Structural Damage at Ure Bank Terrace, Ripon: This damage, resulting from gypsum dissolution and collapse, has led to a loss of support beneath a significant portion of the building [44].

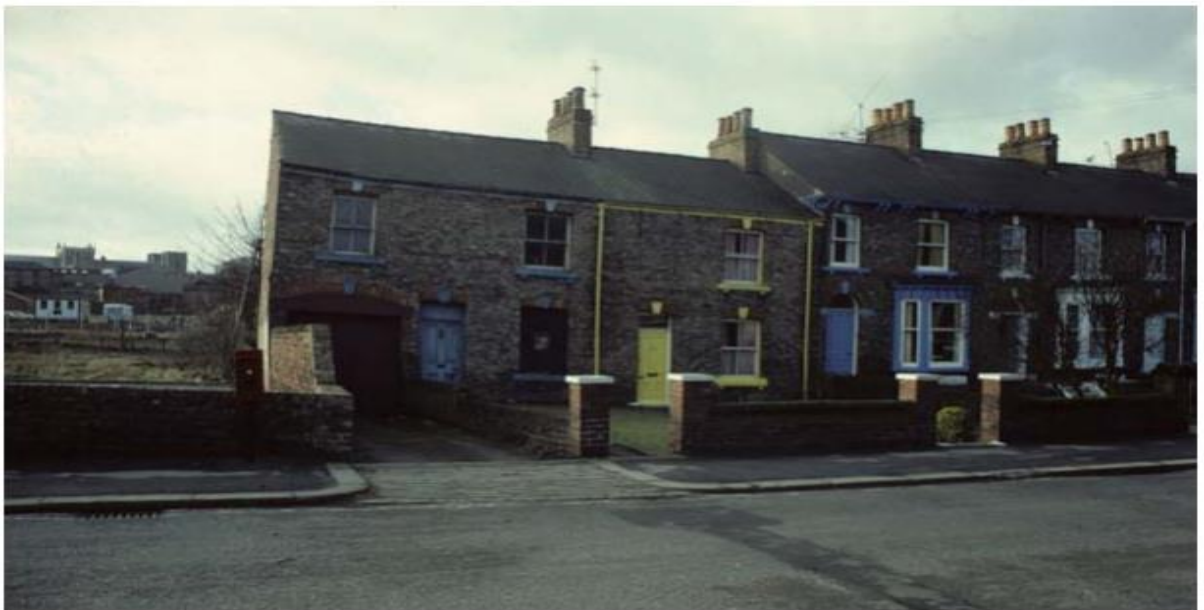
Fig. 1.12. Category 5 Damage from Sagging Buildings: This damage is attributed to gypsum dissolution and related settlement on peat deposits, located on Princess Road, Ripon [44].

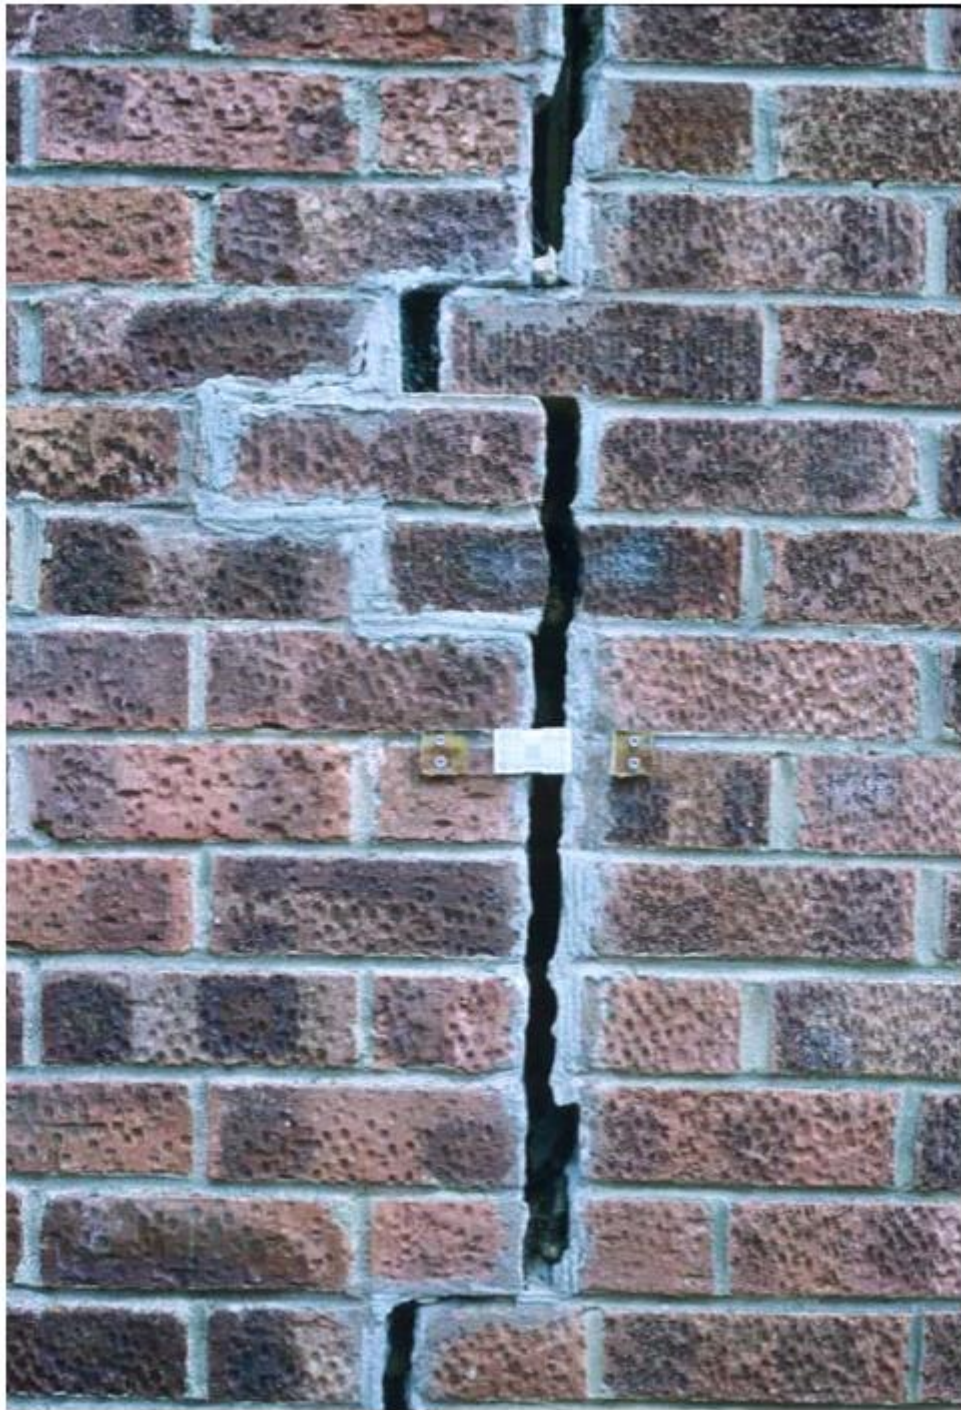
Fig. 1.13. Category 4 Damage: An 18 mm crack in the wall of a house in Hutton Conyers, near Ripon, resulting from subsidence at the edge of a large doline caused by gypsum dissolution. This damage is associated with loss of support and rotation of the floor slab [44].

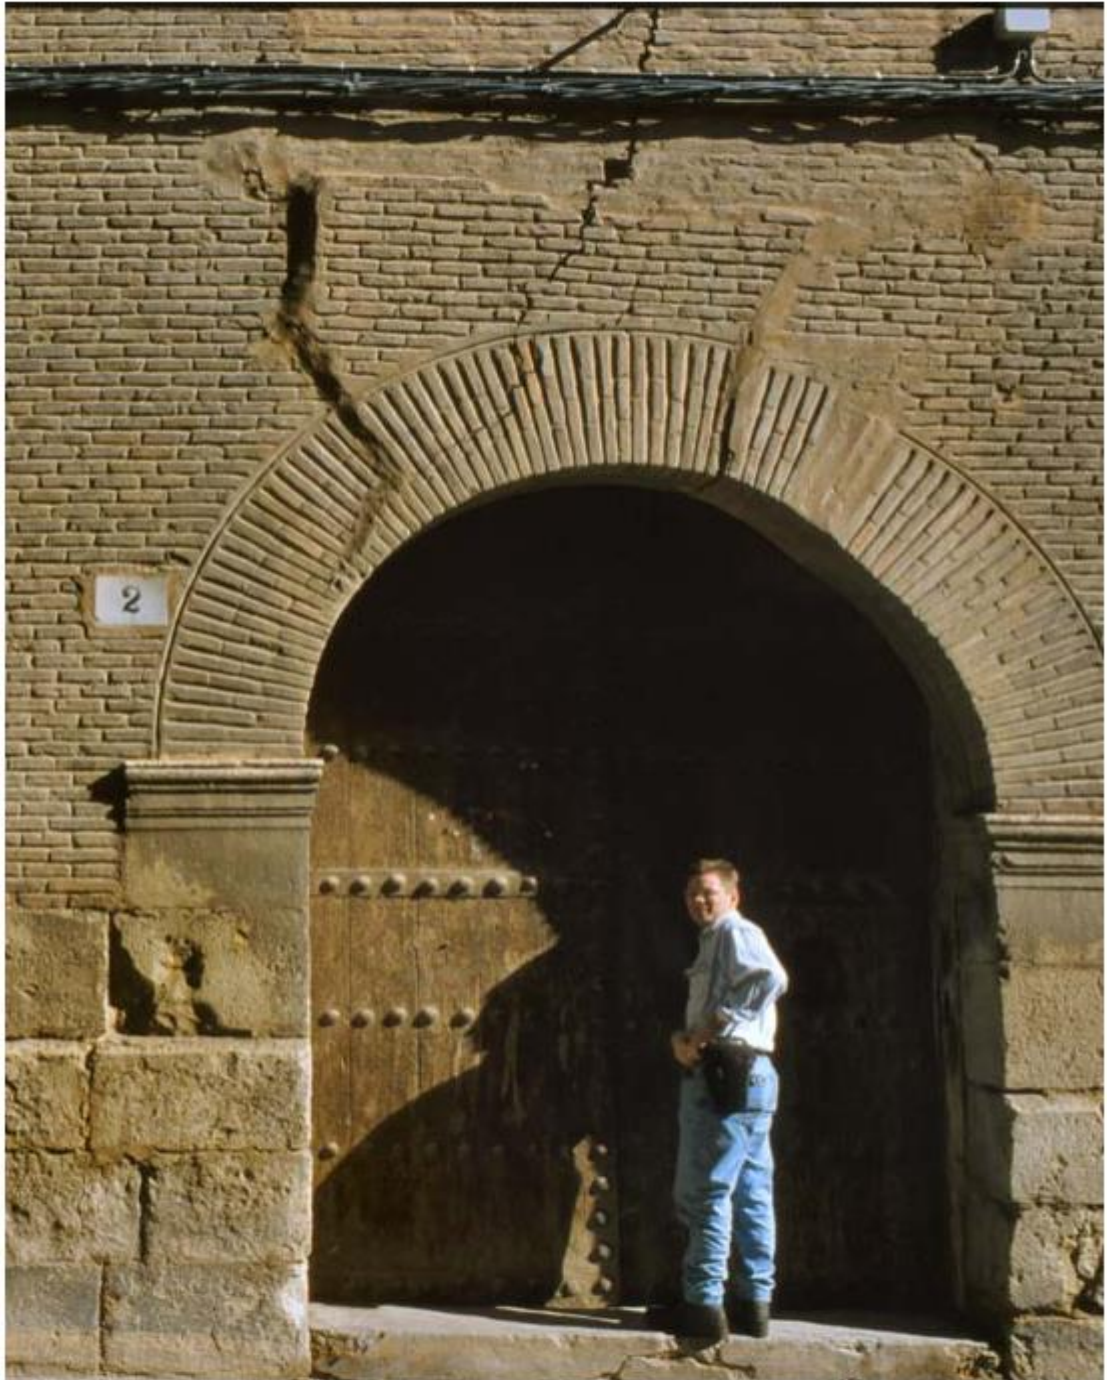
Fig. 1.14. Category 5 Damage: An historic building in Calatayud, Spain, displaying significant damage concentrated in the arch. This damage represents a hogging mode of failure, characterized by loss of support on the right side of the image [44].

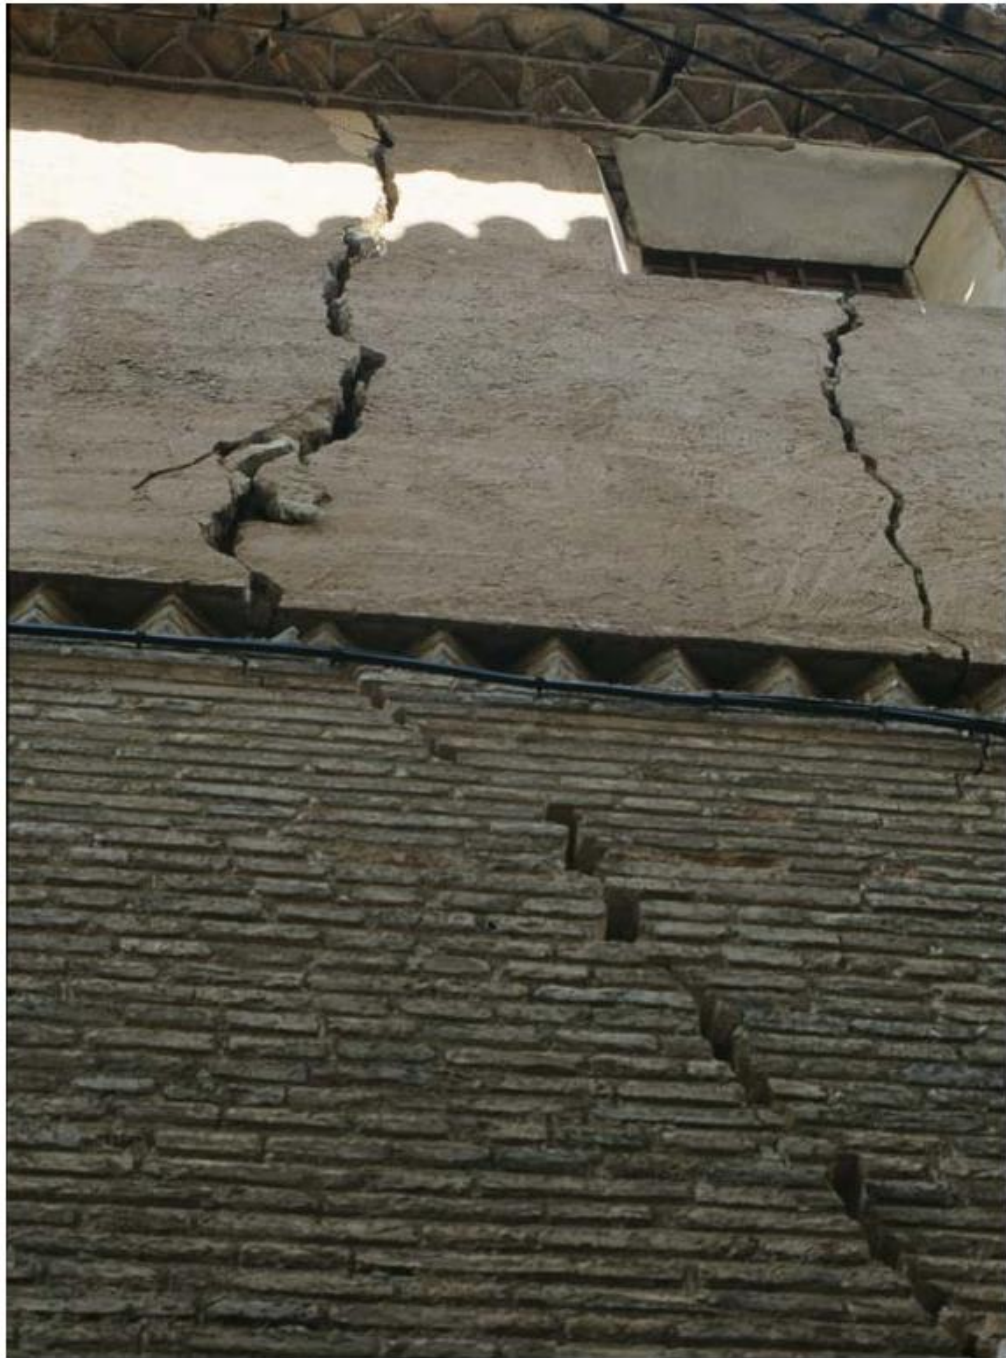
Fig. 1.15. Cracks in the historic Colegiata Sta. Maria La Mayor building in Calatayud, Spain, with some cracks reaching widths of up to 30 mm, while others are even larger. The extent of the damage justifies a Category 5 classification [44].

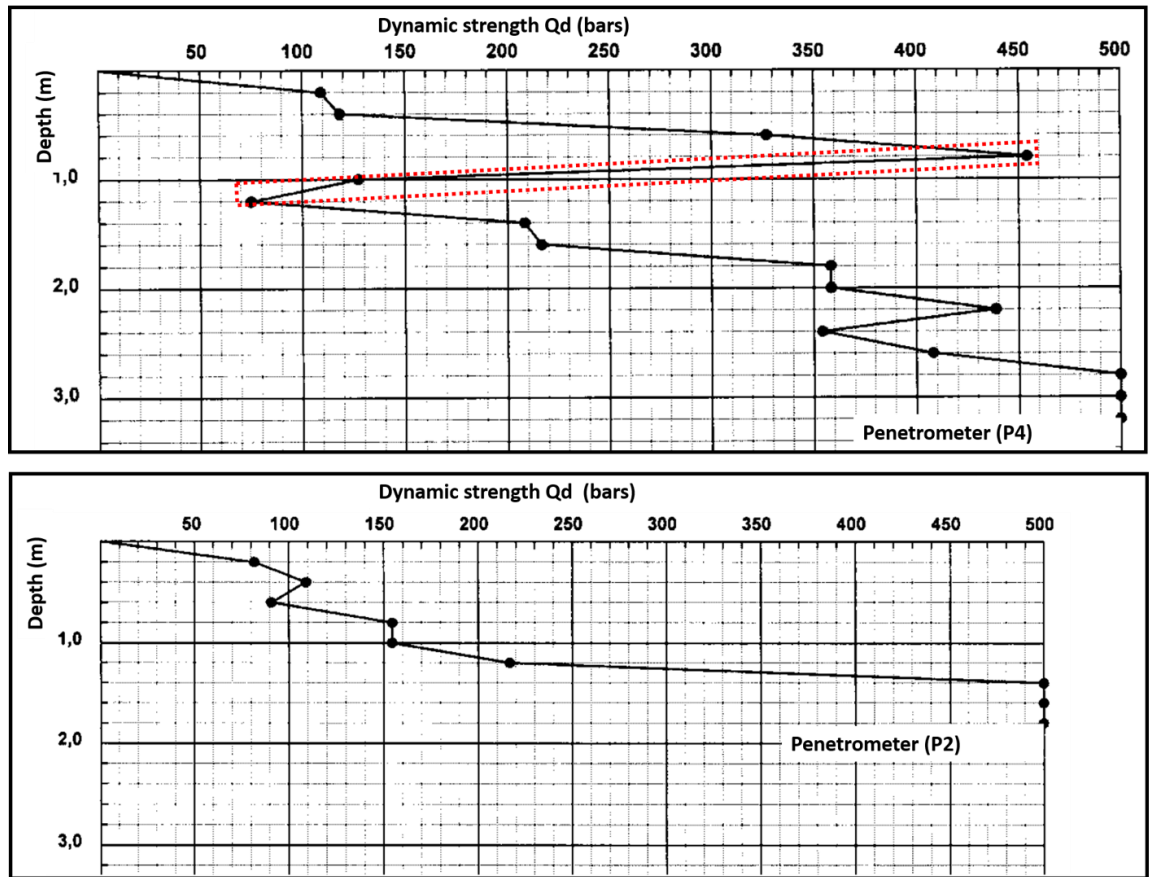
The fifty-five penetrometer tests conducted provided penetrograms, with resistance plotted on the x-axis and depth on the y-axis, indicating that the sites generally exhibited very high soil resistance to penetration, up to refusal (Allowable bearing capacity of 1.8 bar at an anchor depth of 1.50 meters). However, a critical reassessment of these results revealed a significant concern. Specifically, 18 out of the 55 penetrometer points showed a noticeable drop in resistance at certain intervals, with a severe decrease in dynamic strength at shallow depths of less than 40 cm.

These fluctuations in resistance, despite the overall high values, suggest potential anomalies that require further investigation. The observed anomalies could indicate variations in soil composition, the presence of voids, or other subsurface issues that may compromise the stability of the building foundations in these areas. Understanding the underlying causes of these resistance drops is crucial to ensuring the long-term safety and integrity of structures built on these sites.

Fig. 2.10. Penetrometer tests 4 (P4) and 2 (P2) at area A1 and A2: The P4 showed a noticeable disturbance in the dynamic strength, while the P2 did not exhibit such disturbance.

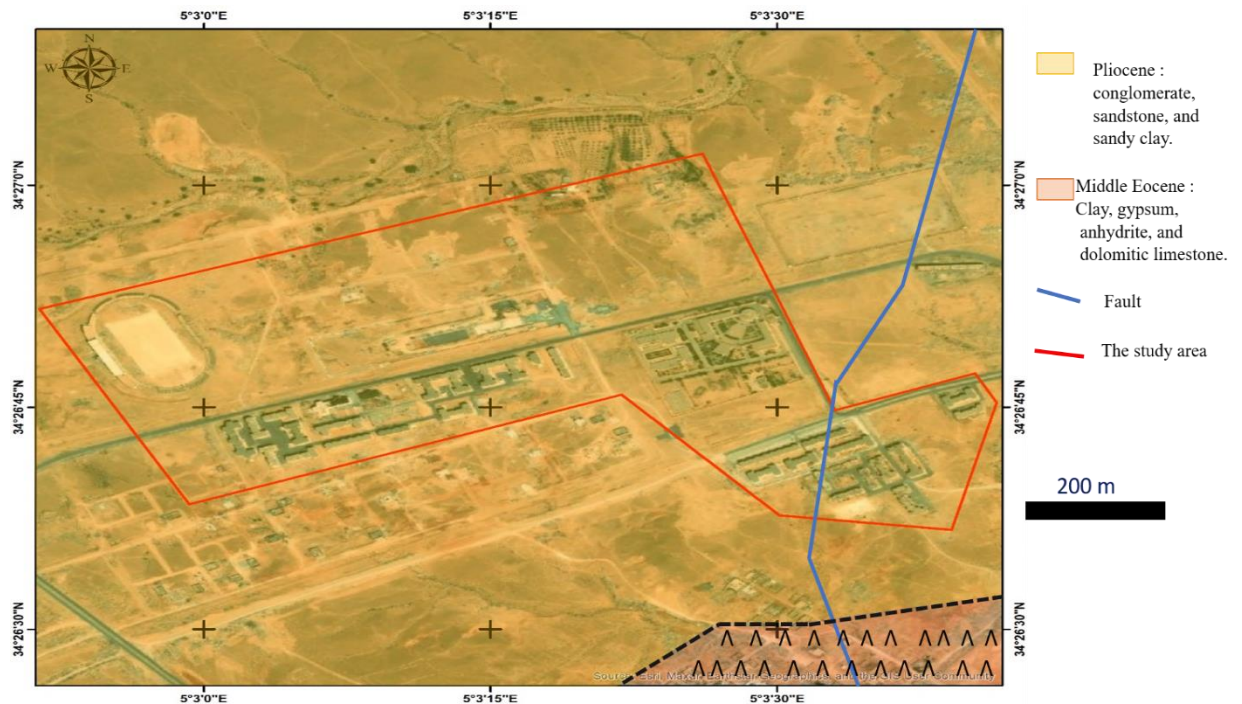
However, according to the georeferencing of the geological map, the study area including affected constructions is situated in a transition zone between the Pliocene, mainly composed of conglomerate, sandstone, and sandy clay, and the middle Eocene formations, primarily composed of clay with outcrops of gypsum, anhydrite, and dolomitic limestone (Fig. 1.13). The presence of gypsum in the form of anhydrite and gypsum in the middle Eocene formations, even if not the first layer where the buildings are anchored (at a depth of 1.5 meters), may provide additional answers to the underlying triggering factors of subsidence and foundation settlement signs.

Gypsum formations or gypsiferous formations beneath the buildings, in contact with unsaturated water, undergo a gypsum dissolution process or destabilization of previous dissolution environments through infiltration. This triggers subsidence and foundation settlement of the buildings.

Fig. 2.13. Localization of the study area according to the georeferencing of the geological map of the region.

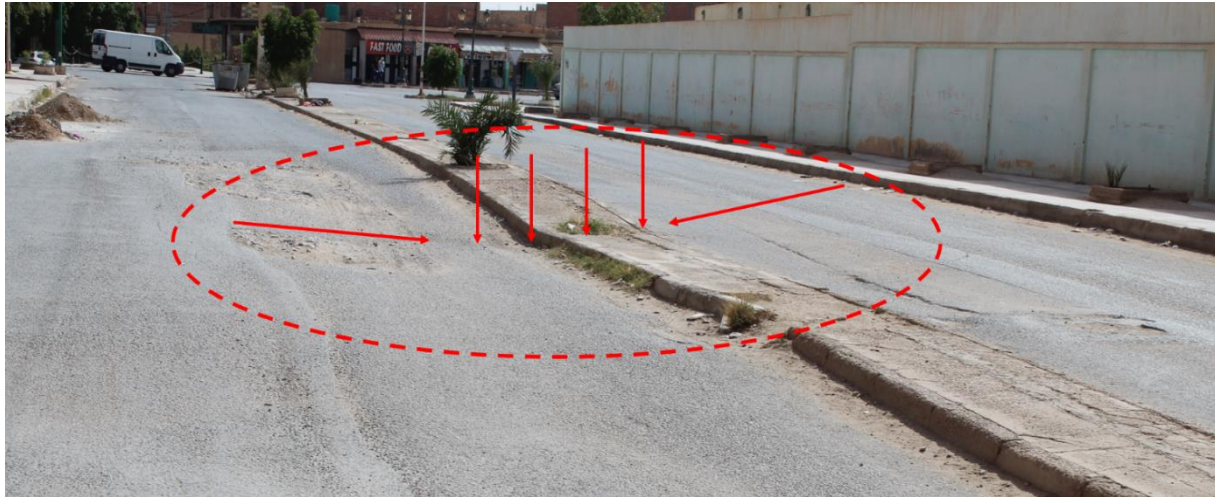
Furthermore, it's worth noting that a notable subsidence event was reported in Sidi Khaled city, located approximately 8 kilometers to the south of the study area (Fig. 2.15). This subsidence event further underscores the geological dynamics and susceptibility to ground movements in this region.

Fig. 2.15. Subsidence that occurs in Sidi Khaled city, approximately 8 kilometers south of the study area.

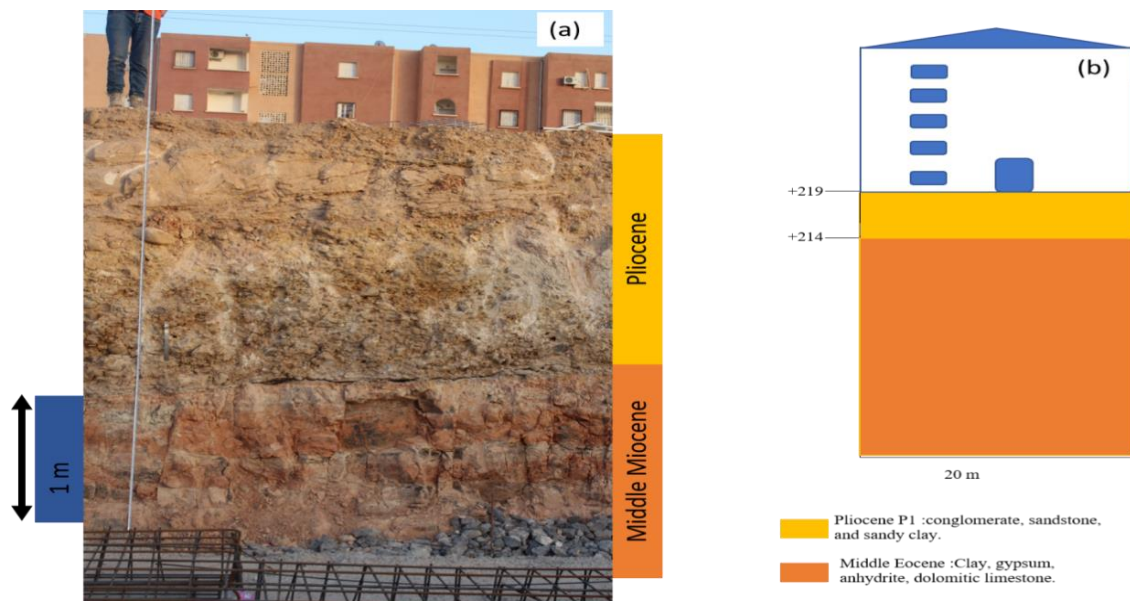
Geological cross-sections were created by georeferencing the geological map of the study region and ensuring their intersection with the building site. Upon analysis, it was determined that the buildings are situated on a surface layer dating back to the Pliocene epoch. This layer, ranging from 3 to 7 meters thick, comprises sandstone, conglomerate, and sandy clay. Beneath this layer lies a middle Eocene formation characterized by clay, with exposures of gypsum, anhydrite, and dolomitic limestone (Fig. 3.2 (b)).

The excavation analysis corresponds well with the geological cross-sections created through georeferencing the regional geological map (Fig. 3.2). The soil predominantly consists of a mixture of conglomerate, sandstone, and sandy clay from the Pliocene epoch, underlain by clay from the middle Eocene epoch. However, indications of deformations, particularly faults within the upper layer, were observed, along with the presence of middle Eocene clay at relatively shallow depths. Such deformations and variations in geological formations may stem from various factors, such as tectonic activities, weathering, or erosion.

Fig. 3.2. The geological section under the buildings: (a) Real section parallel to the buildings 7 and 8; (b) Cross section parallel to the buildings, based on the georeferencing of the geological map of the region under study.

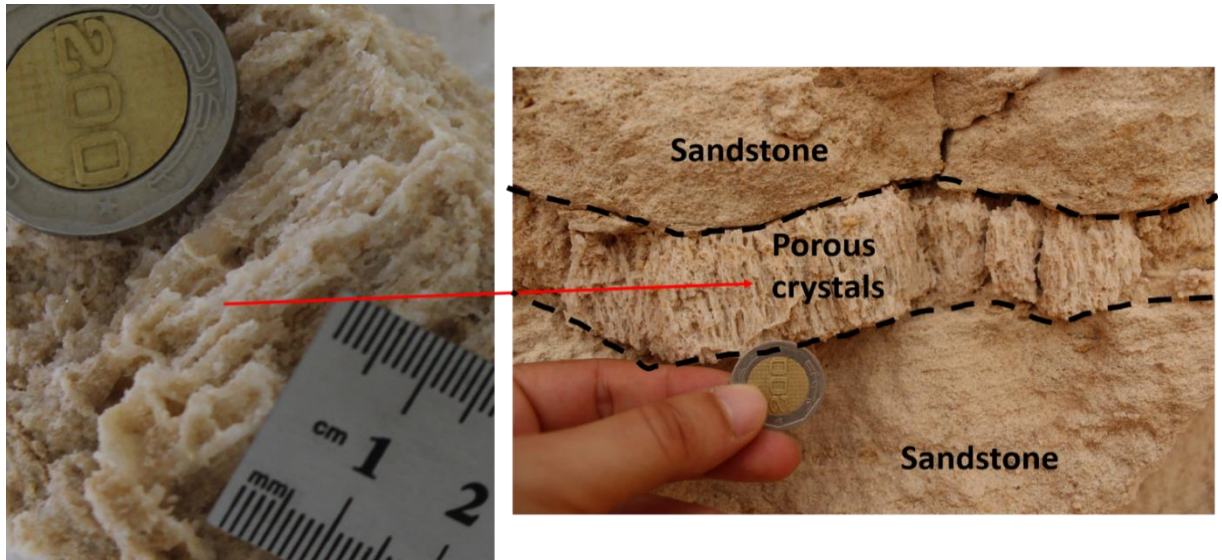
- *Porous crystals crystals embedded within the sandstone:* These crystals exhibit a thickness of approximately 10 cm and display a fragile nature, suggesting potential weakness or instability within this segment of the sandstone formation (Fig. 3.3);

Fig. 3.3. Porous crystals within the sandstone.

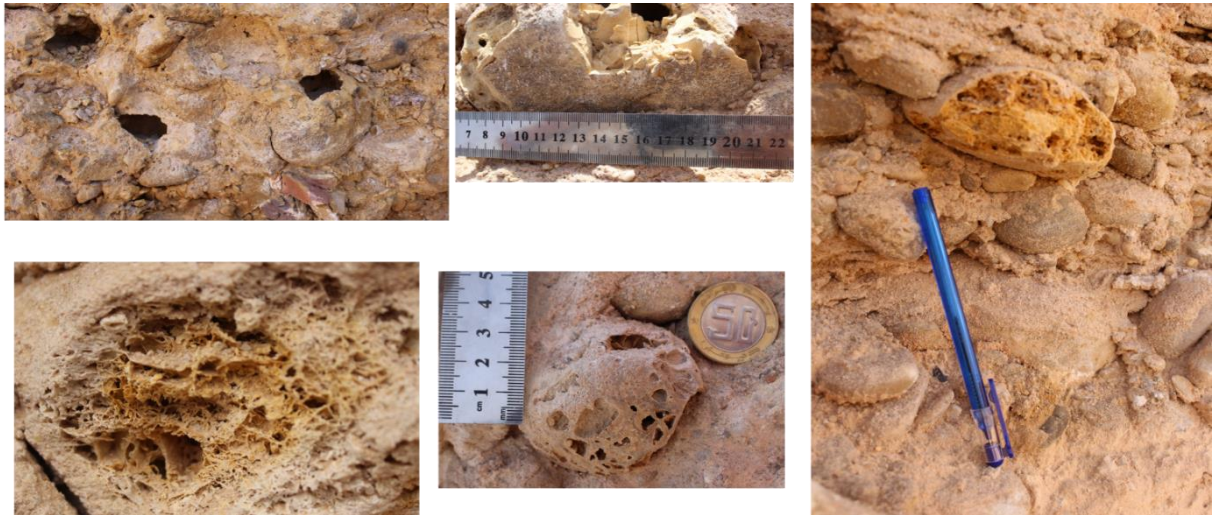
- *Geodes within the conglomerate:* These geodes harbor voids or crystals akin to those identified in the sandstone, indicating potential similarities in the geological processes that have influenced both formations (Fig. 3.4).

Fig. 3.4. Geodes detected within the conglomerate formations.

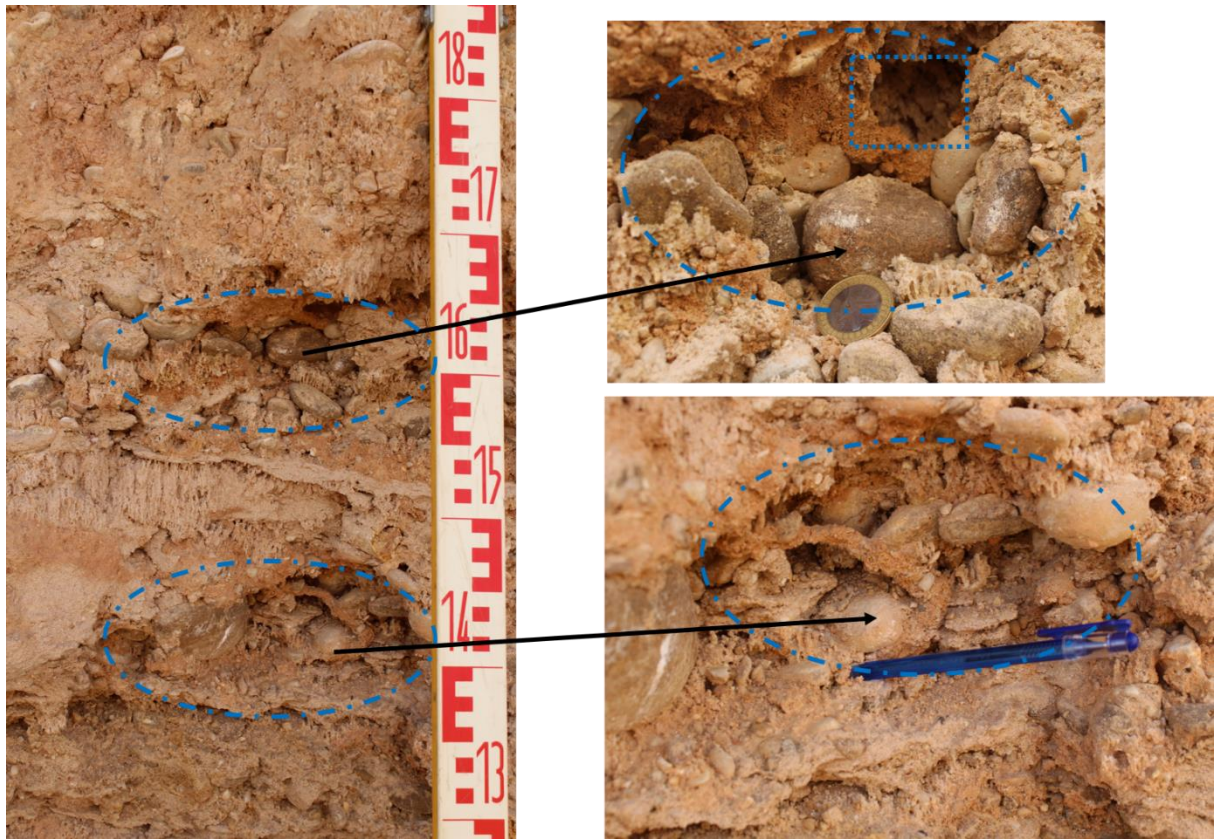
- *Regions of voids present in both formations:* The identification of zones characterized by minimal conglomerate matrix and highly porous layers, influenced by geological processes affecting both formations, implies the potential presence of cavities within the Pliocene formation. This indicates an unstable building foundation anchoring layer (Fig. 3.5) ;

Fig. 3.5. Areas exhibiting minimal to no conglomerate matrices and highly permeable layers of chemically altered sandstone.

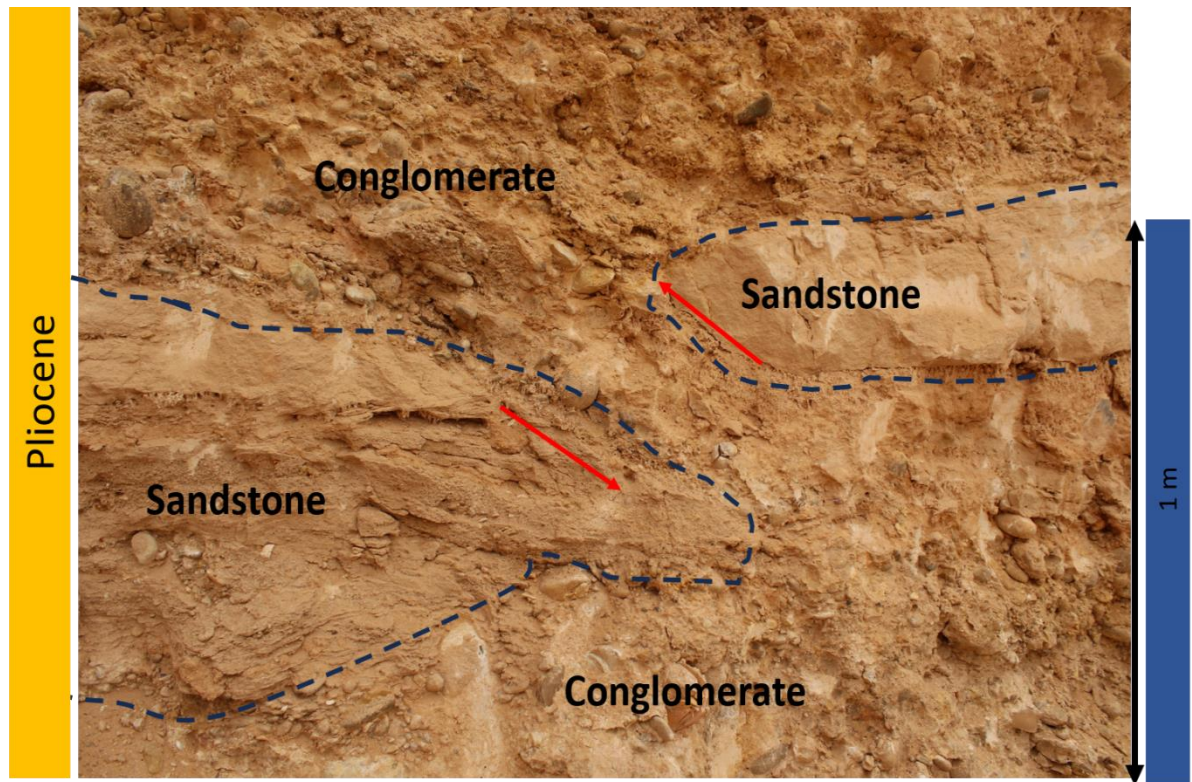
- *Deformations in the sandstone:* The presence of deformations in the sandstone could be associated with tectonic activity or other geological processes that may have affected the formation over time (Fig. 3.6).

Fig. 3.6. Faults observed within the sandstone exhibiting reverse deformation.

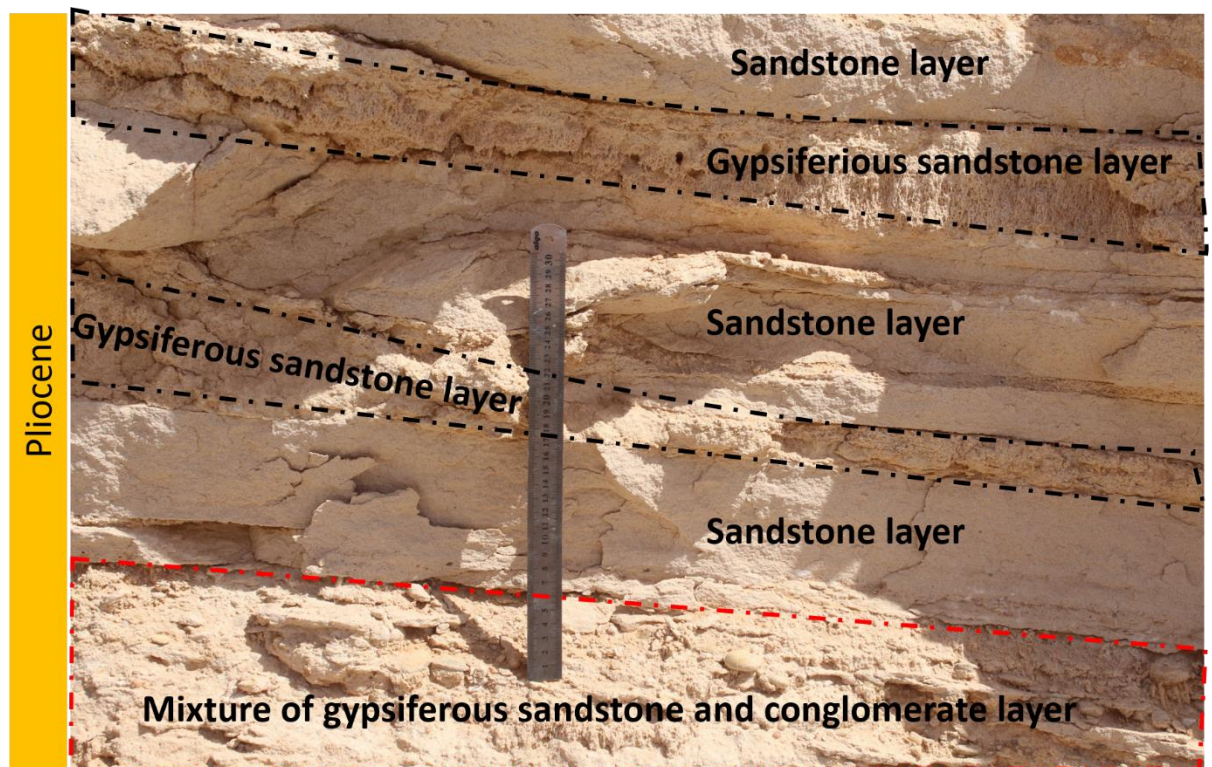
In contrast, the Pliocene layer revealed a significant presence of gypsum forms within the porous crystals found in the sandstone. Specifically, the composition of these crystals comprised 46.97% gypsum forms, including 31.05% gypsum, 15.52% hemihydrate, and 0.4% anhydrite. This gypsiferous sandstone was identified as interbedded within the sandstone formation (Fig. 3.8). Additionally, the sandstone formation itself exhibited a minor presence of gypsum, totaling 2.06% across all three gypsum forms. However, the predominant mineral observed in the sandstone was calcite, accounting for a substantial 90.92% of its composition.

Fig. 3.8. Gypsiferous sandstone interbedded within the Pliocene sandstone layer.

It's noteworthy to mention that the oxidation of pyrite stands as a potential mechanism fostering the development of gypsum within the sandstone. The interaction of pyrite with oxygen and water over time triggers its oxidation, yielding sulfuric acid. Subsequently, this acid can react with calcium-rich rocks like limestone or dolomite, culminating in the formation of gypsum [65], [65,66]. This mechanism offers a viable explanation for the occurrence of both dolomitic geodes and gypsiferous crystals which detected in the calcareous sandstone unearthed at the excavation sites.

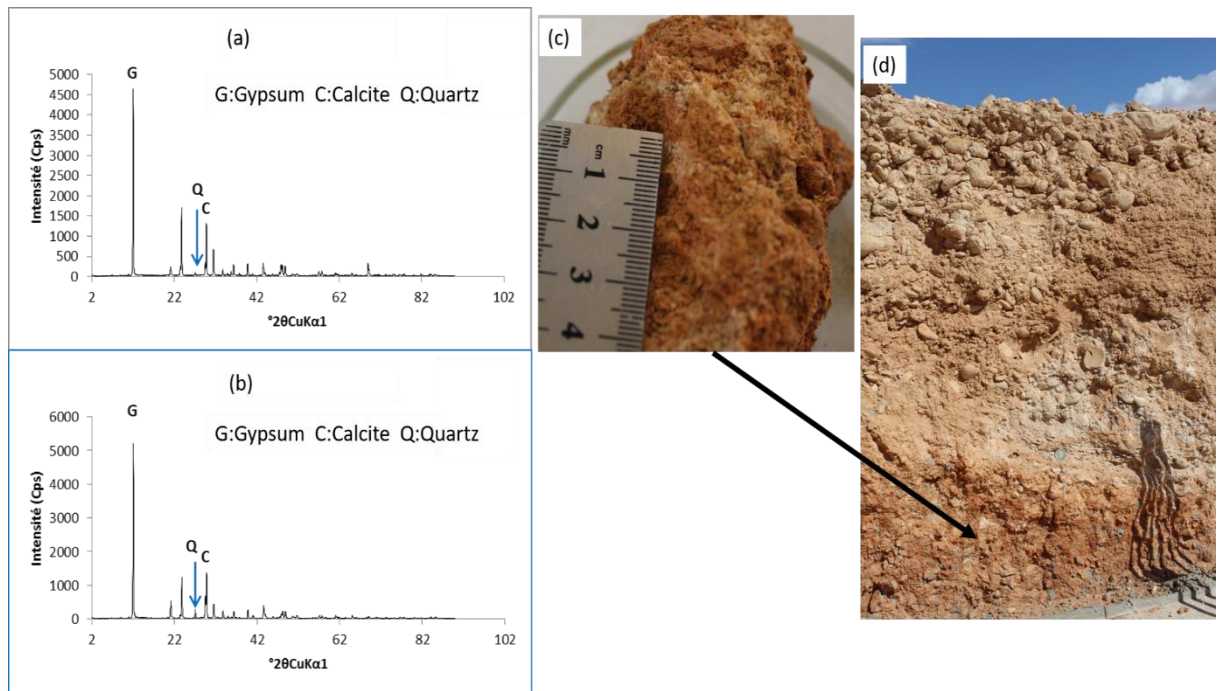
Moreover, thorough examination of the sandy clay samples revealed a notable abundance of gypsum forms in samples 1 and 2 (Fig. 3.9). These forms comprised approximately 40% and 43% of the compositions of samples 1 and 2, respectively. In contrast, calcite constituted 59% and 51% of the composition, while quartzite accounted for only 1% and 6% of the two samples.

Fig. 3.9. Analysis of sandy clay: (a) X-ray diffraction spectrum of sample 01; (b) X-ray diffraction spectrum of sample 02; (c) Sandy clay sample; (d) Random distribution of sandy clay at the first Pliocene layer.

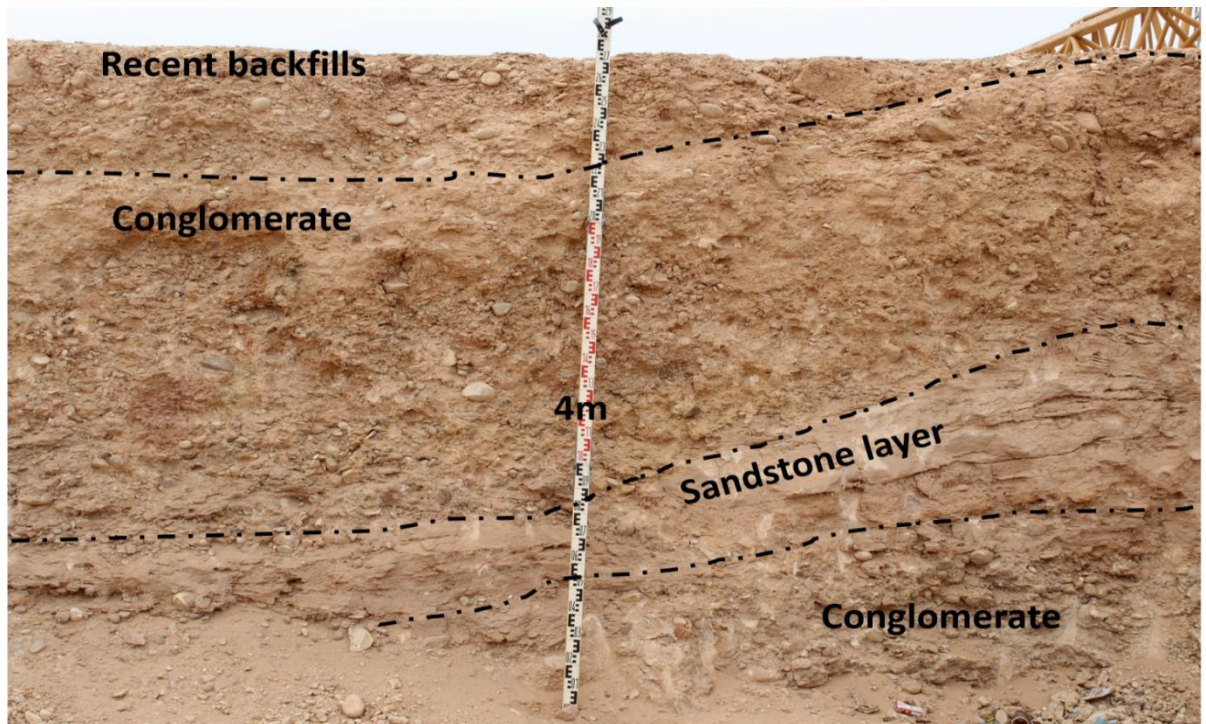
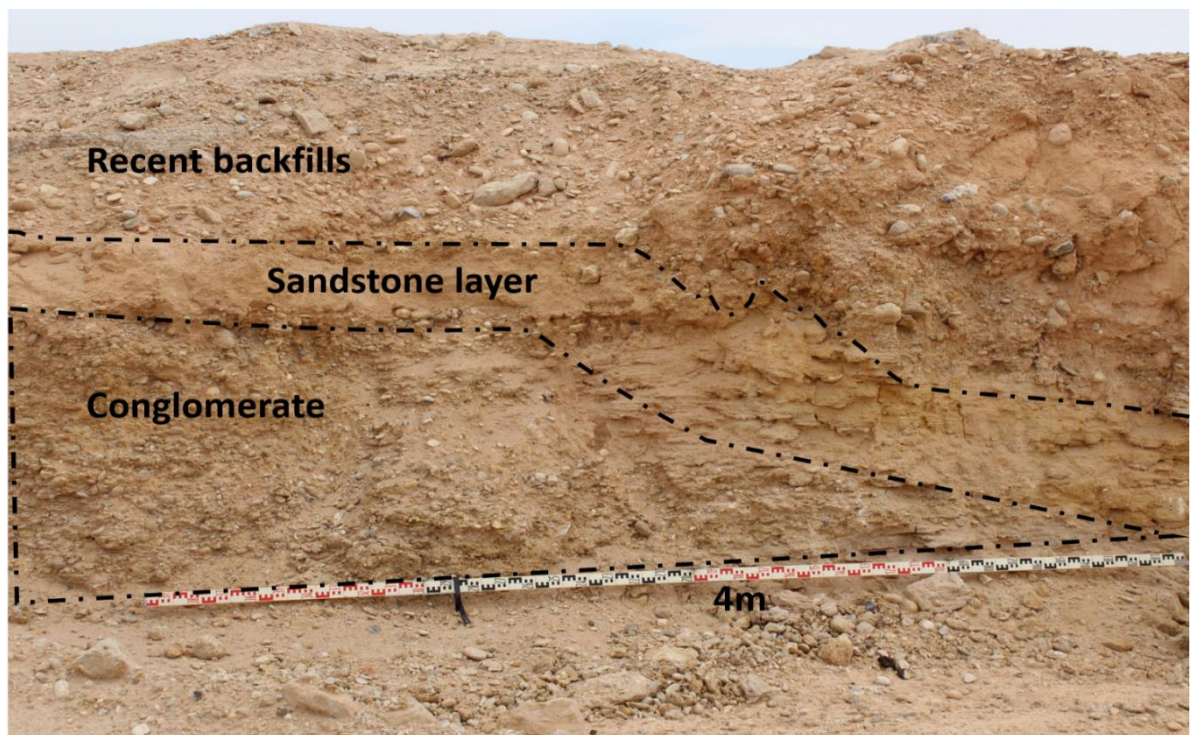
Additionally, it's crucial to acknowledge that isolated and combined footings anchored within this formation might lead to non-uniform building movements instead of uniform ones. This disparity in movement can be ascribed to the erratic distribution of gypsiferous soils in terms of depth and area, making the soil exceedingly heterogeneous (Fig. 3.10).

Fig. 3.10. The erratic distribution of the geological formations containing gypsiferous soil, both in terms of depth and area, within the initial Pliocene layer.
