Université Mohamed Khider – Biskra
Faculté des Sciences et de la technologie
Département de Génie Civil et Hydraulique
Réf :

Thèse de Doctorat LMD
Spécialité : GENIE CIVIL
Option : MATERIAUX DE CONSTRUCTION

Etude de la pathologie des fissurations de bâtiment suite au phénomène de dissolution du gypse cas des bâtiments de Ouled Djellal.

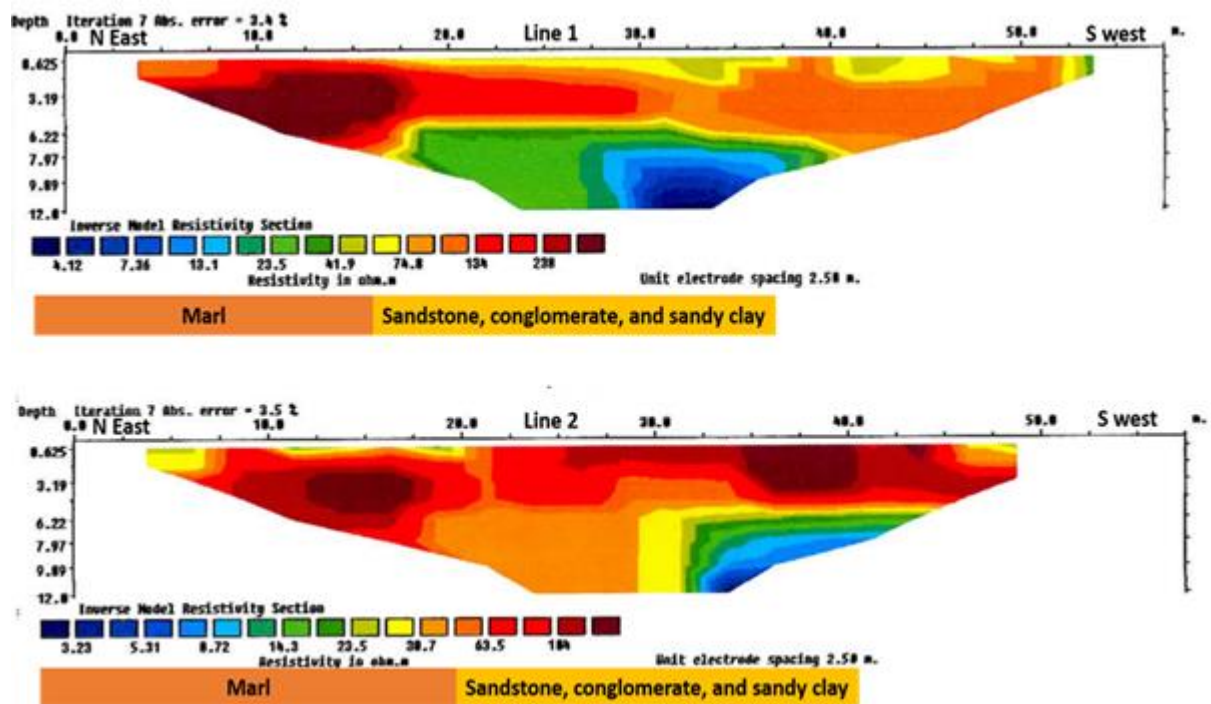
The in-situ electrical resistivity measurements, carried out at a depth of 12 meters, provided valuable insights into the soil composition. Within this depth, two distinct layers were identified: the Pliocene layer overlaying the middle Miocene marly layer (Figs. 3.12, 3.13, and 3.14). Interestingly, the electrical resistivity of the Pliocene layer, consisting of conglomerate, sandstone, and sandy clay, was notably higher than that of the marls present in the middle Miocene layer.

Fig. 3.12. Evaluation of the soil utilizing electrical resistivity tomography lines 1 and 2.

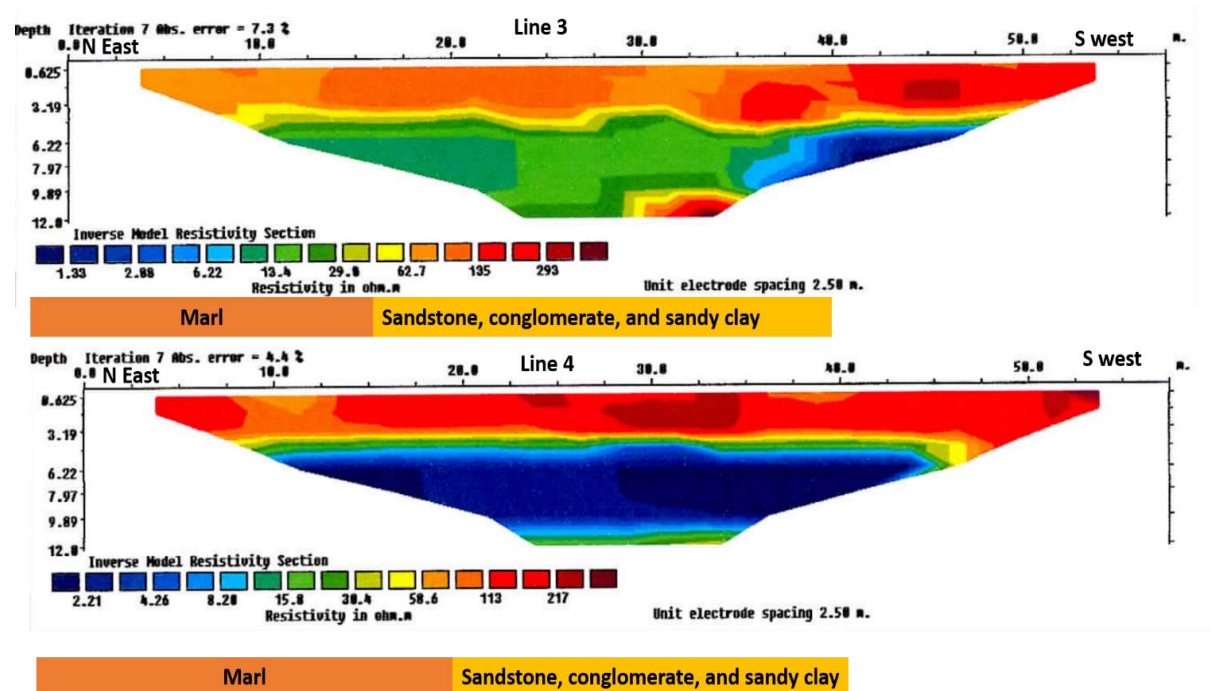
Fig. 3.13. Evaluation of the soil utilizing electrical resistivity tomography lines 3 and 4.

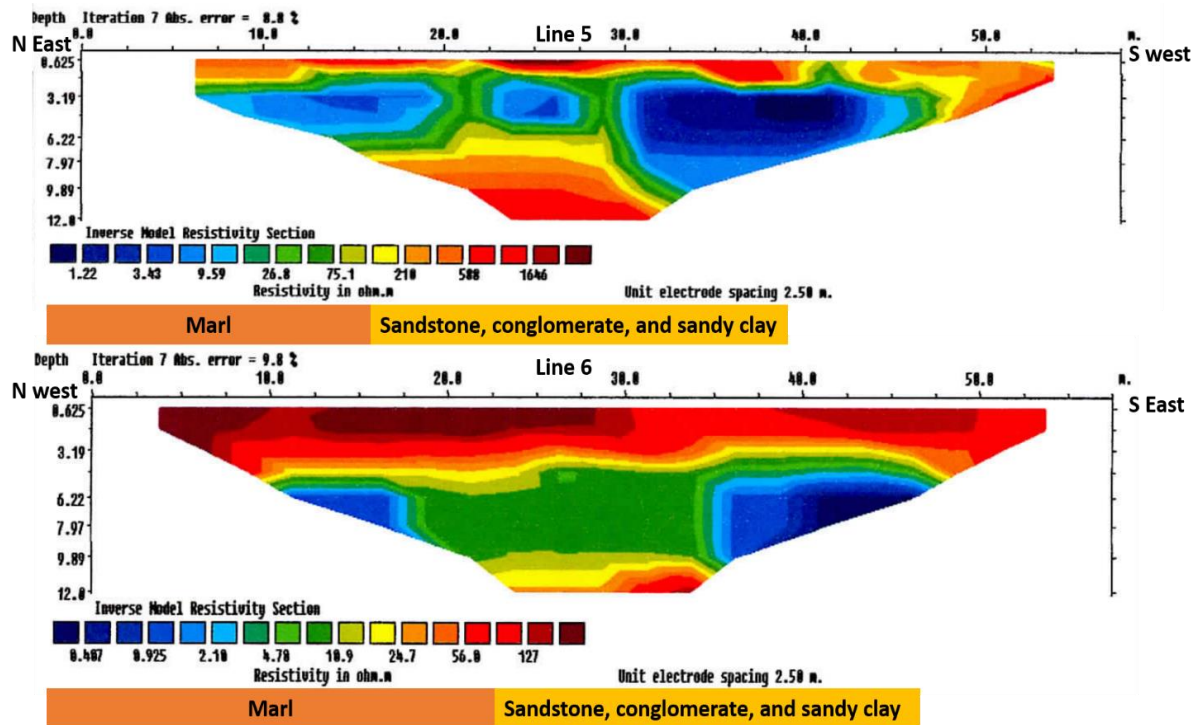
Fig. 3.14. Evaluation of the soil utilizing electrical resistivity tomography lines 5 and 6.

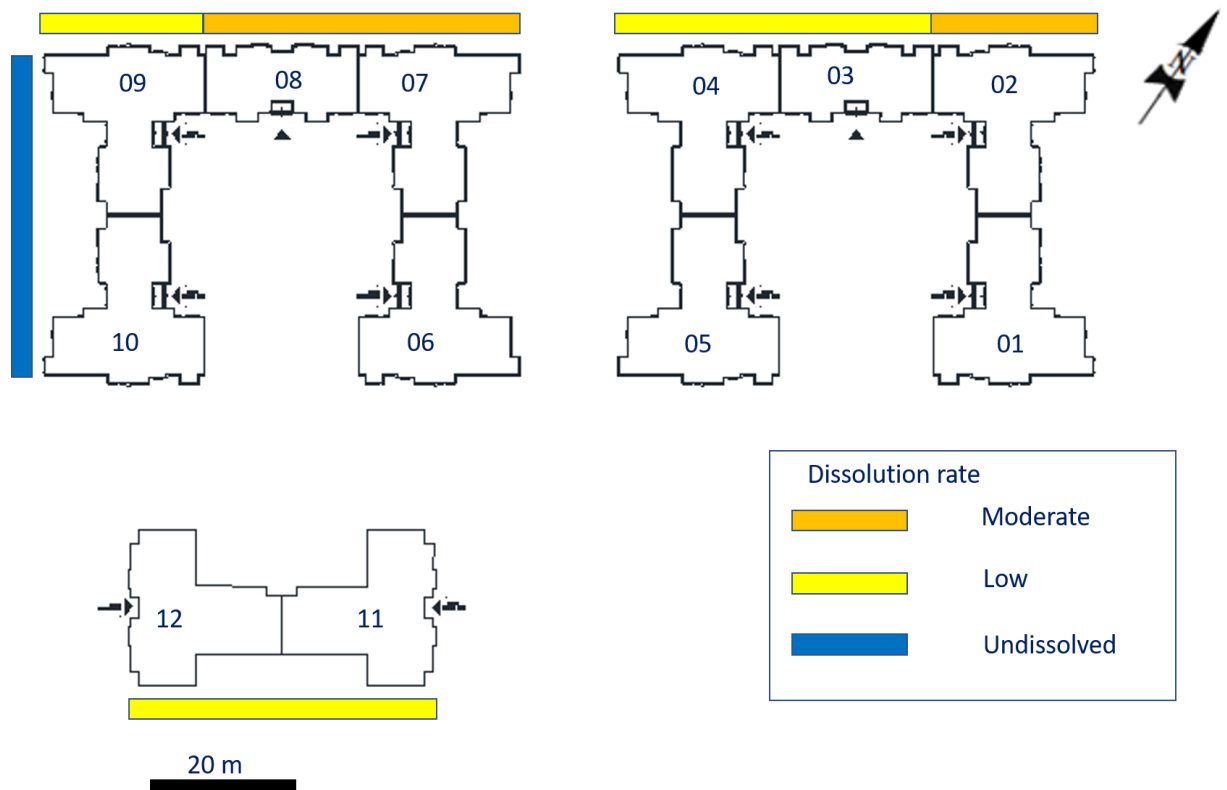
Additionally, it's crucial to recognize that the distribution of the evaluated dissolution rate was not consistent along the length of the lines. The in-situ electrical resistivity measurements aided in mapping the distribution of the predominant assessed gypsum dissolution rate parallel to the affected buildings (Fig. 3.15).

Fig. 3.15. Variations in the dissolution rates along the buildings affected by the phenomenon.

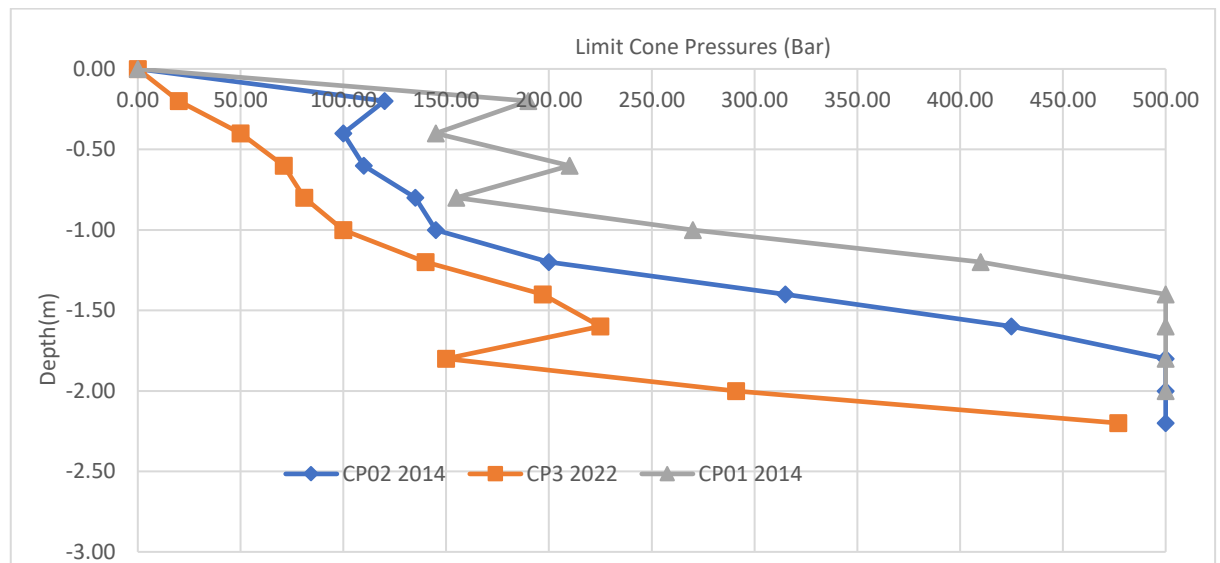
1. These findings highlighted that the pressure required to penetrate the soil in 2022 was generally lower compared to that of 2014, as depicted in Fig. 3.16.

Fig. 3.16. Contrasting the results of the penetrometer tests conducted in 2022 and 2014 adjacent to building 1 Area 1.

The observed decrease in the recorded limit cone penetration pressure tests can be attributed to the process of gypsum dissolution and particle transportation when exposed to concentrated water flow, such as water infiltration from detected leakages within the first Pliocene layer. This process may result in the formation of new small cavities or the reactivation of existing ones, leading to the enlargement of these voids. Without external loads to collapse the soil structure at the measurement points, the void ratio of the soil increases without a change in volume. This enlargement facilitates easier penetration by the cone, as evidenced by the lower penetration limit values observed in 2022 compared to those recorded in 2014.

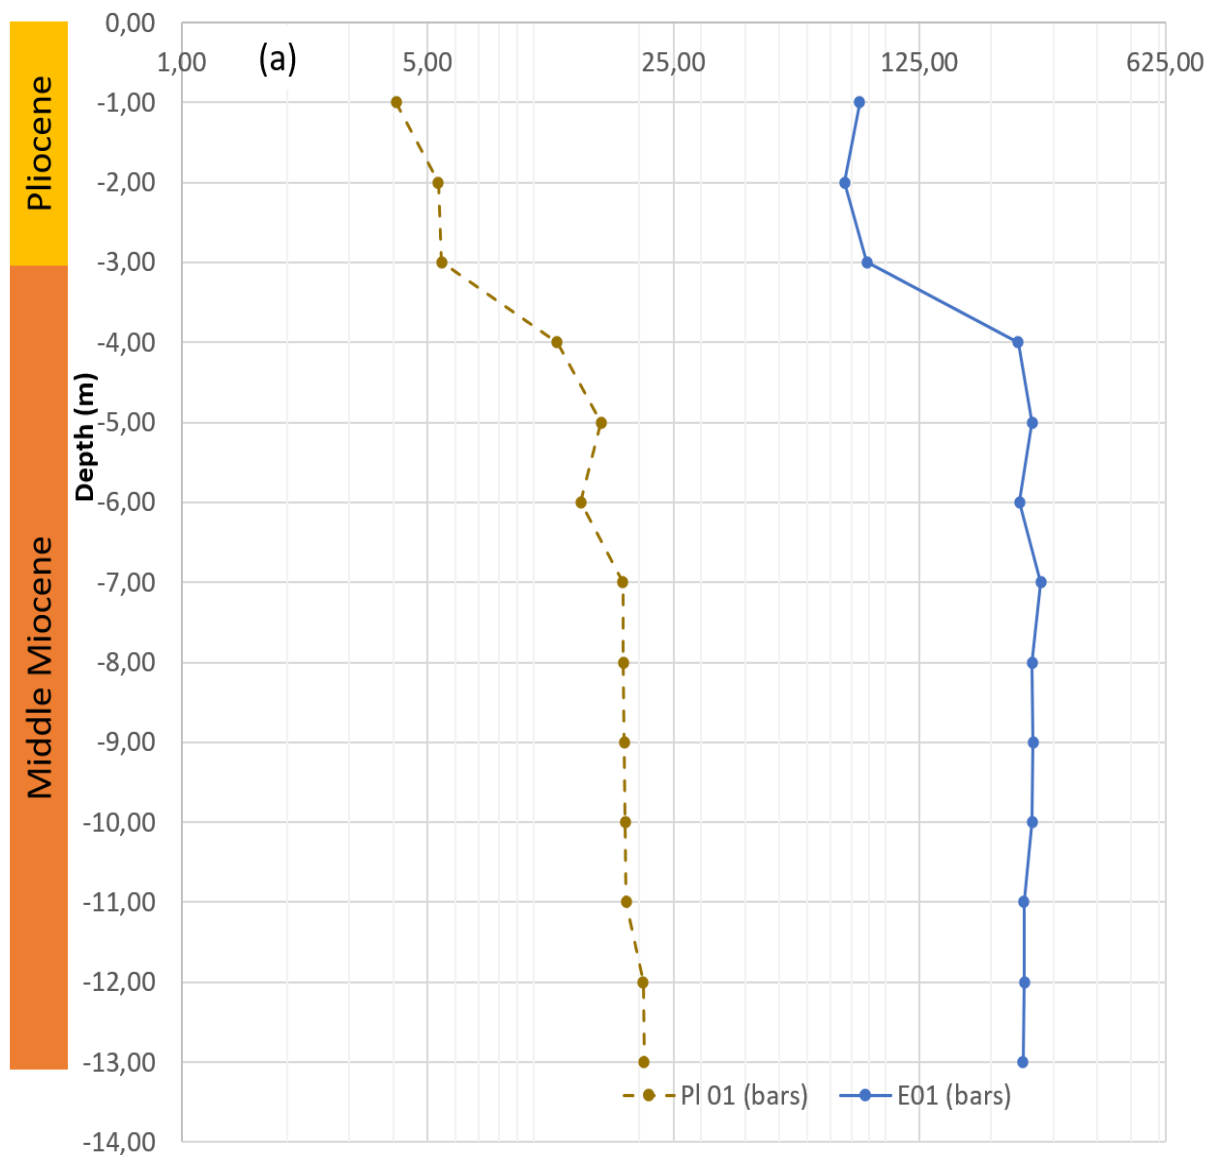
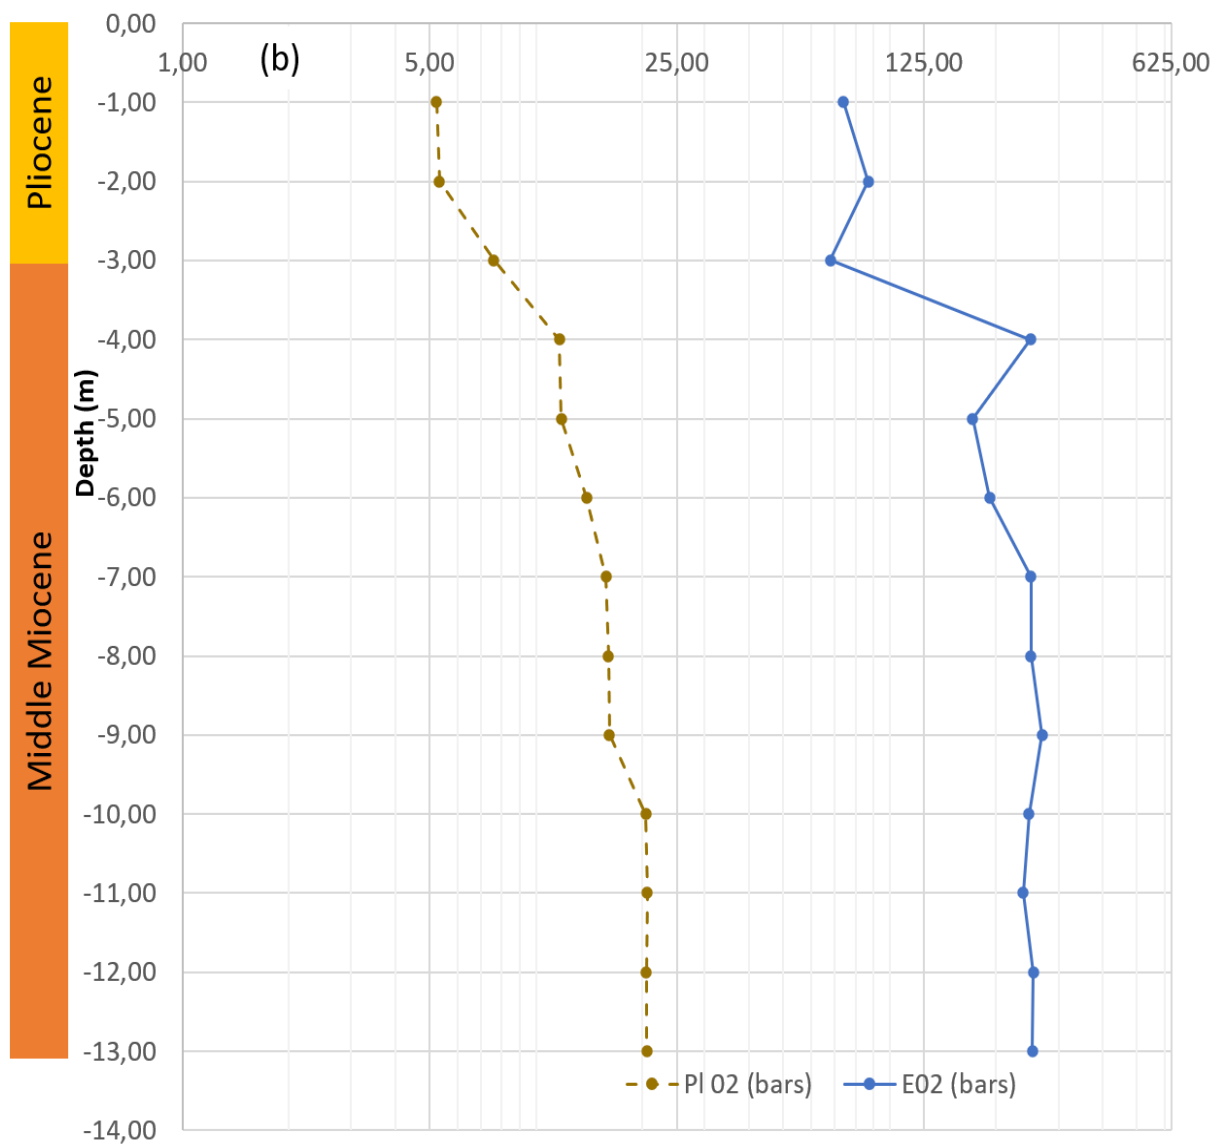
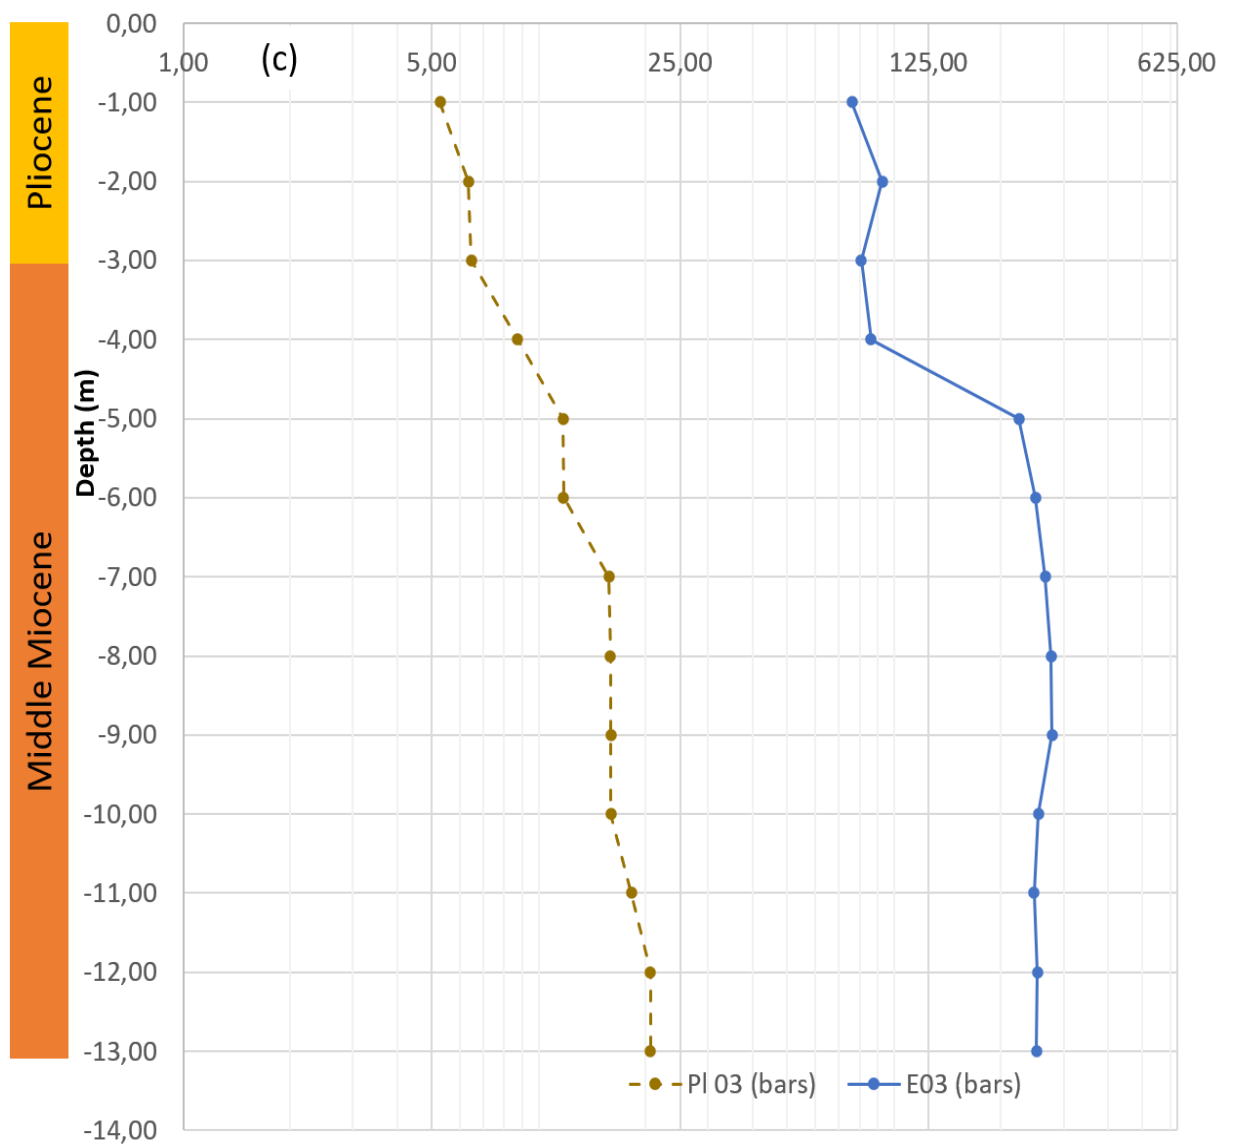
The Menard pressuremeter tests (MPTs) yielded intriguing insights into the soil's limit pressure, extending to a depth of 13 meters. Across SP01, SP02, and SP03 tests, the pressure limit values varied from 4.08 to 20.66 bars, as depicted in the figure below (Fig. 3.17).

Fig. 3.17. Assessment of Pressuremeter Modulus (E) and Limit Pressure (PI) of Soil Using Menard Pressuremeter Tests: (a) SP01 results, (b) SP02 results, (c) SP03 results.

The analysis of results from the Menard pressuremeter tests unveiled a discernible pattern: the limit pressure values displayed an upward trend with increasing depth. Particularly noteworthy was the observation that within the initial layer of the Pliocene, where a moderate gypsum dissolution rate was evident, the limit pressure values derived from the SP01, SP02,

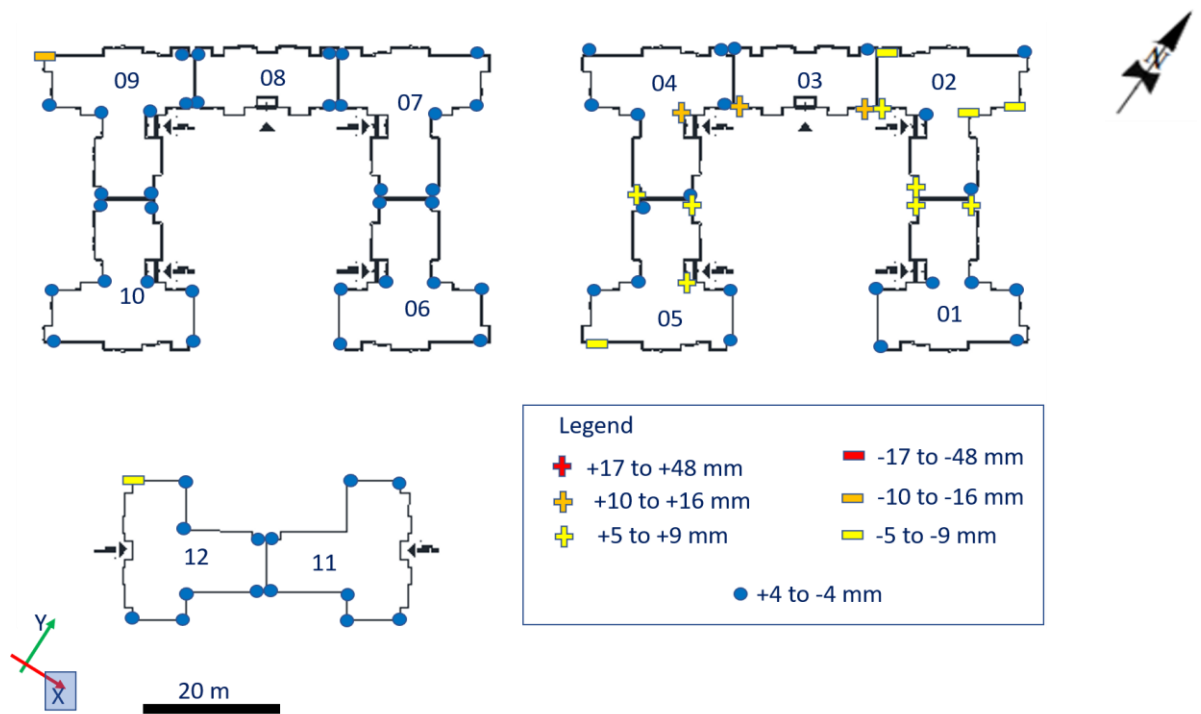
Fig. 3.18. Horizontal displacement along X-axis of the building's ground level.

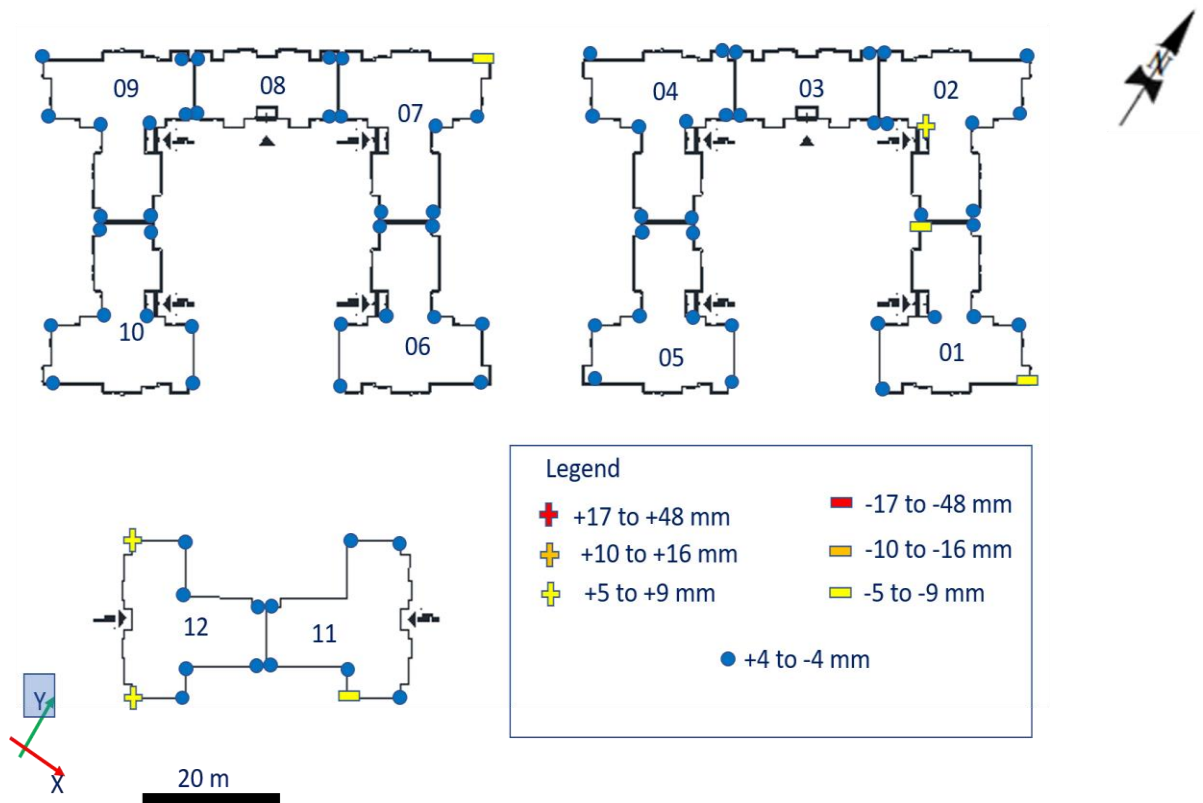
Fig. 3.19. Horizontal displacement along Y-axis of the building's ground level.

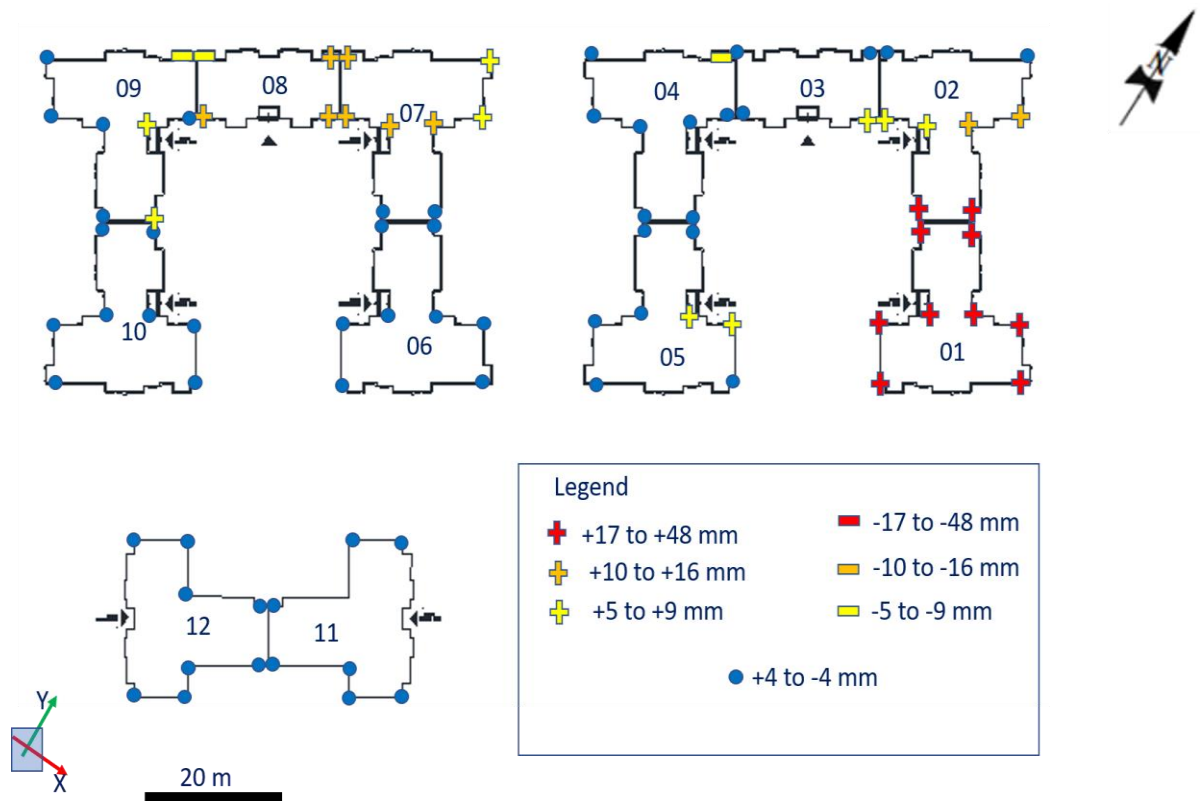
Fig. 3.20. Vertical displacement along Z-axis of the building's ground level.

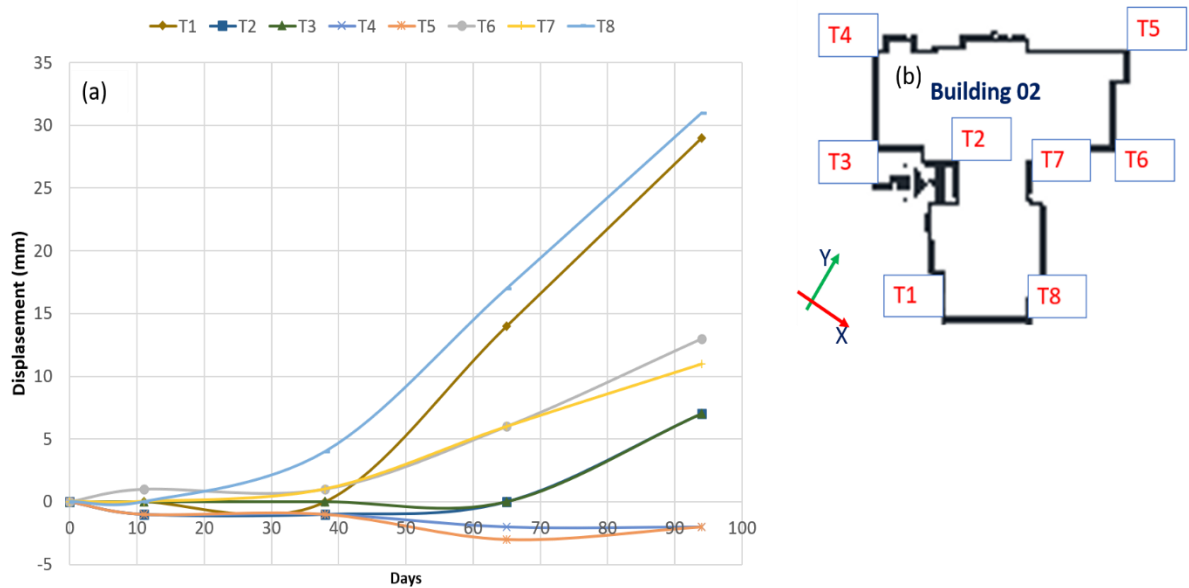
- The reflective targets positioned on the upper section of building 2 (targets 4 and 5) demonstrated settlements of less than 5 mm throughout the 94-day observation period.

Conversely, those situated on the lower part of the building displayed upward movements, indicating differential settlement within the structure. This phenomenon is likely attributable to the moderate dissolution rate observed parallel to this building's facade. Such dissolution can reduce the soil's strength, leading to settlements in some areas and heaving or upward displacement in others. Fig. 3.22 suggests that varying gypsum dissolution rates may contribute to differential settlement by causing soil compaction and stability variations. However, the maximum values observed for T8 and T1 are influenced by the building's foundation design. Building 2, where targets T1 and T8 were installed, shares combined foundations with building 1. Consequently, the recorded upward heaving of these targets is consistent with the displacements observed at targets T7 and T8 of building 1 (Fig. 3.22).

Fig. 3.22. Building 2: (a) Targets movement versus time (days), (b) Targets references on the building.

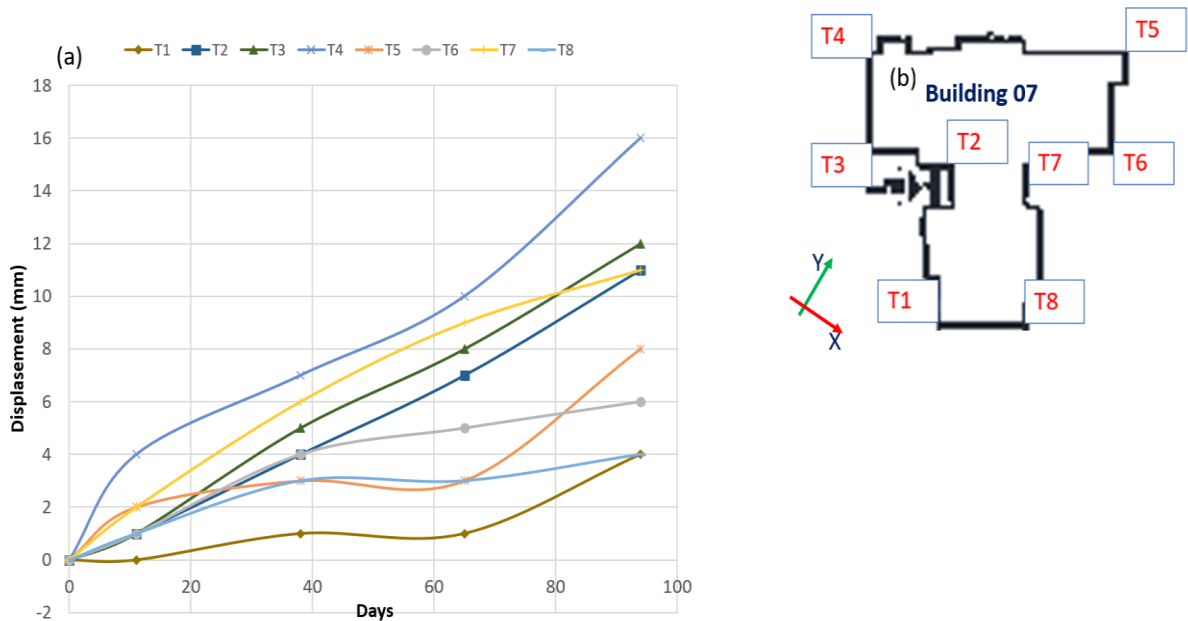
- Throughout the 94-day monitoring period, all reflective targets installed on building 7 displayed upward movements, indicating a sagging pattern akin to that observed in the first building. Consequently, the central area of this building experienced settlement, while its periphery exhibited upward displacement or heaving. This differential movement is likely attributable to the moderate dissolution rate observed parallel to the building's facade. The presence of such a dissolution rate may lead to alterations in soil strength, causing settlement in certain areas while others undergo heaving or upward displacement, as depicted in Fig. 3.23.

Fig. 3.23. Building 7: (a) Targets movement versus time (days), (b) Targets references on the building.

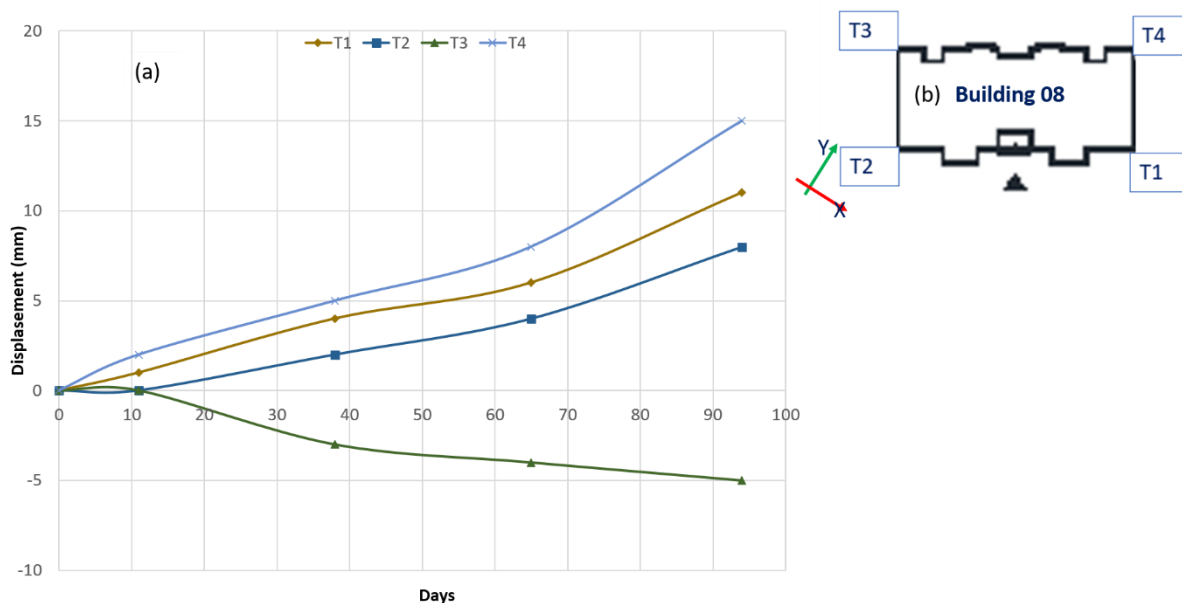
- During the 94-day monitoring period, reflective targets 1, 2, and 4 on building 8 displayed upward movements, while target 3 exhibited settlements, mirroring a

pattern of differential settlement akin to that observed in building 2. This differential movement is likely linked to the moderate dissolution rate observed parallel to the building's facade, as illustrated in Fig. 3.24.

Fig. 3.24. Building 8: (a): Targets movement versus time (days), (b): Targets references the building.

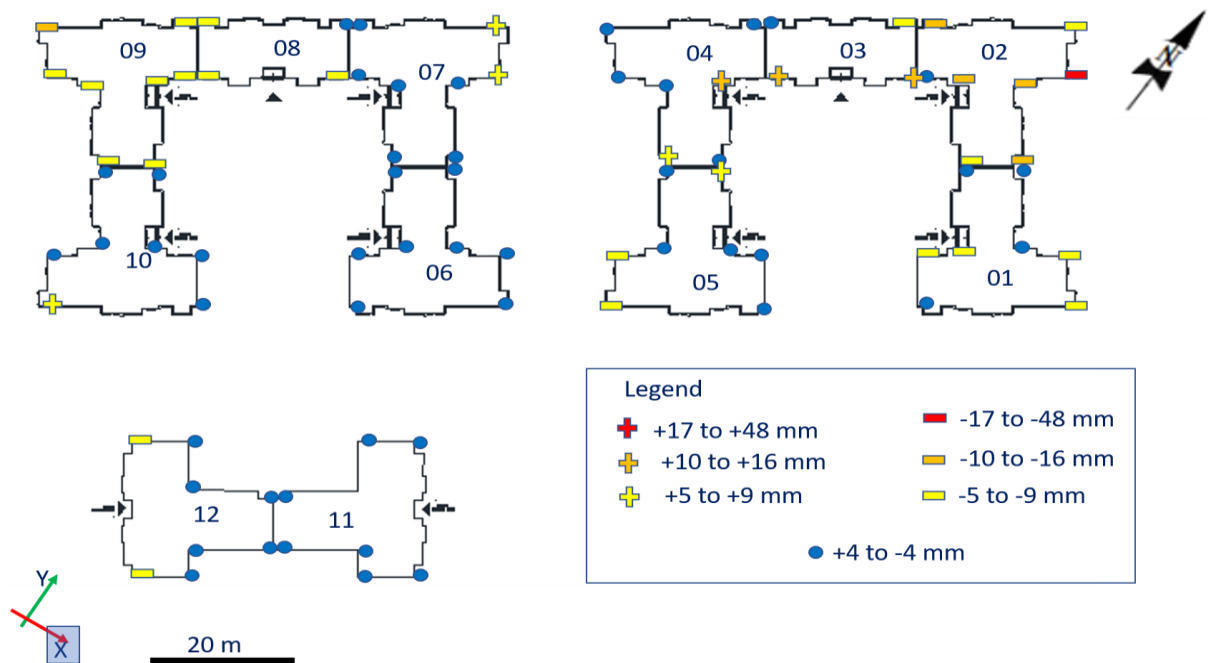
On the fourth floor, extensive displacements were observed along all three axes, as depicted in Fig. 3.25, 3.26, and 3.27. However, there were no substantial changes noted along the z-axis. Instead, significant tilting of the building was observed along the x and y axes, indicating notable differential movement at the foundation level, likely the primary cause of the building's tilting. Regrettably, this phenomenon led to several adverse effects, including horizontal structural cracks in the columns. Additionally, there were instances of divergence among adjacent buildings, resulting in divergence that increases along the height of the adjacent

Fig. 3.25. Horizontal displacement along X-axis of the building's fourth-floor level.

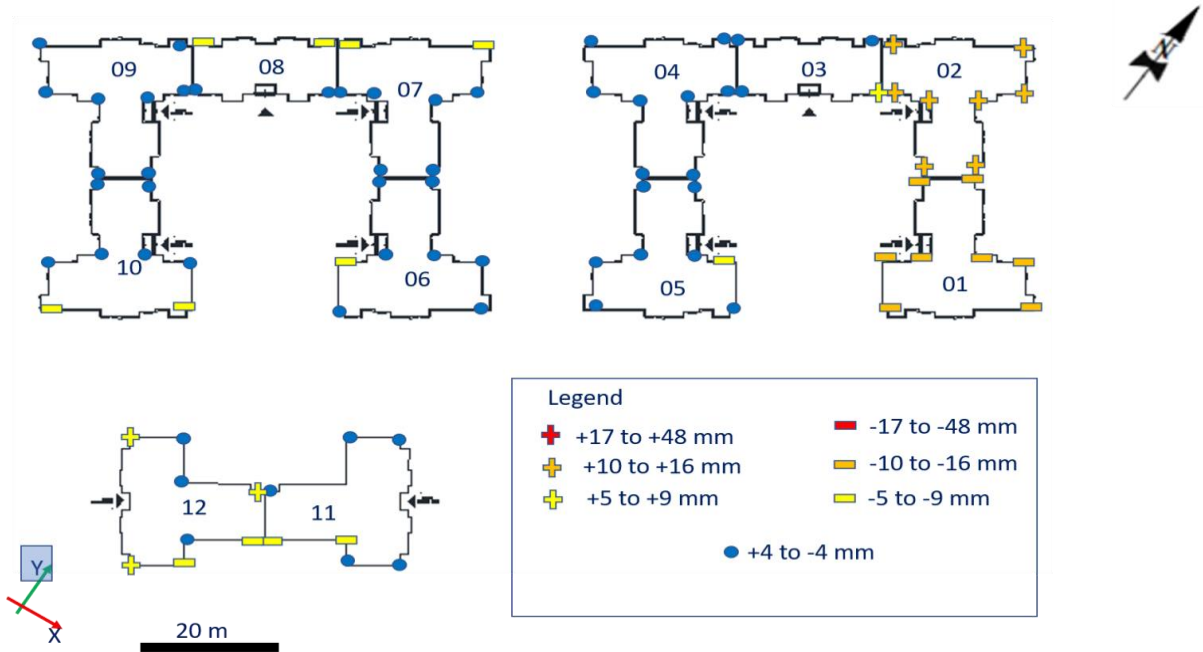
Fig. 3.26. Horizontal displacement along y-axis of the building's fourth-floor level.

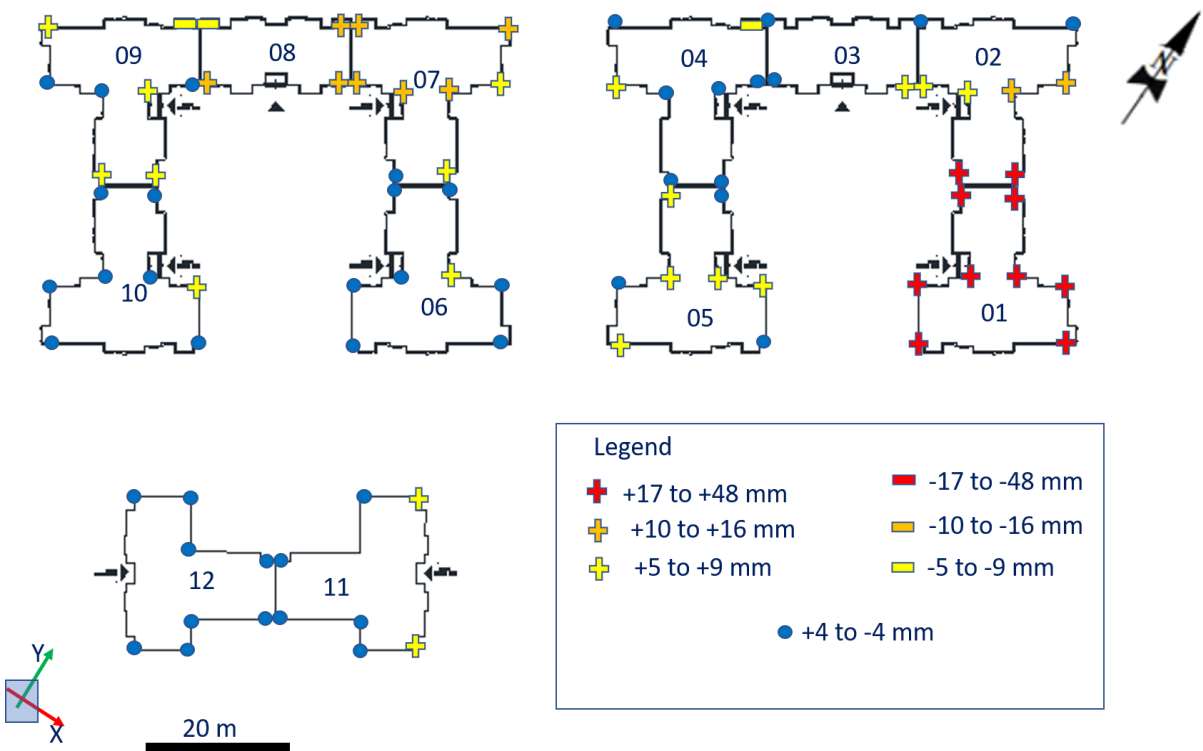
Fig. 3.27. Vertical displacement along Z-axis of the building's fourth-floor level.

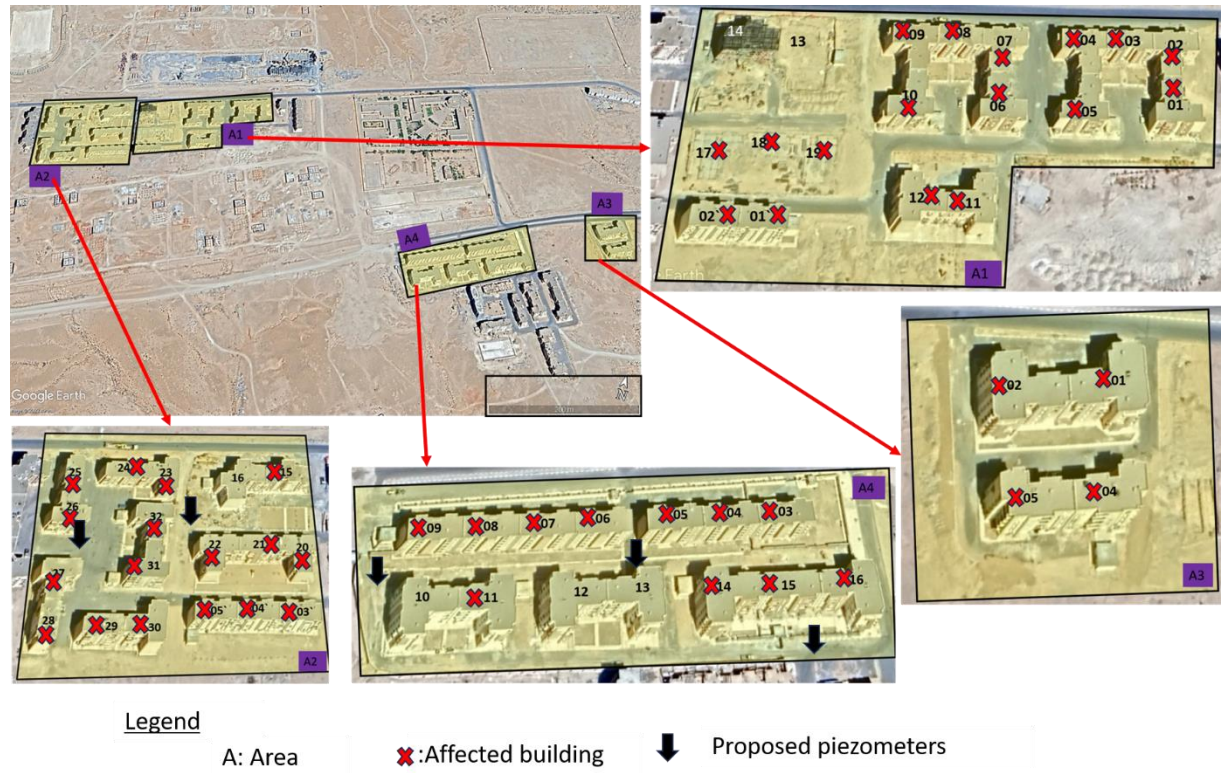
Fig. 4.1. The new proposed piezometers across the buildings study area.

However, concerning the buildings in Areas A1, A2, A3, and A4 in the northwestern part of Ouled Djellal city, it has been observed that Areas A1 and A4 require the installation of new

piezometers. Specifically, two piezometers are recommended for Area A1 and three for Area A4 (Fig. 4.1). Furthermore, some of the existing piezometers in Areas A1 and A3 may need to be relocated or replaced to ensure effective monitoring.

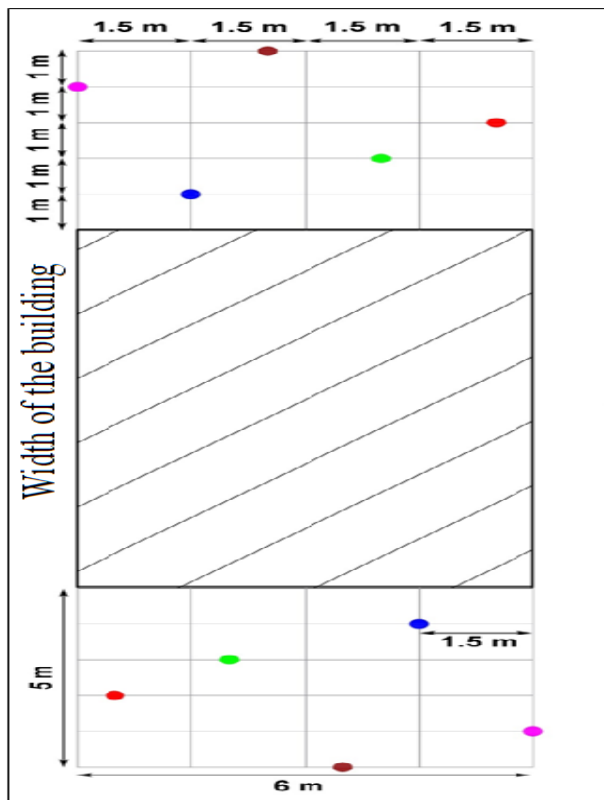
Fig. 4.9. Plan view of the proposed Meshing.

- Injection of primary boreholes: These are 6m wide strips, each comprising 10 boreholes distributed along the width of the buildings (Fig. 4.9) spaced 22m apart.

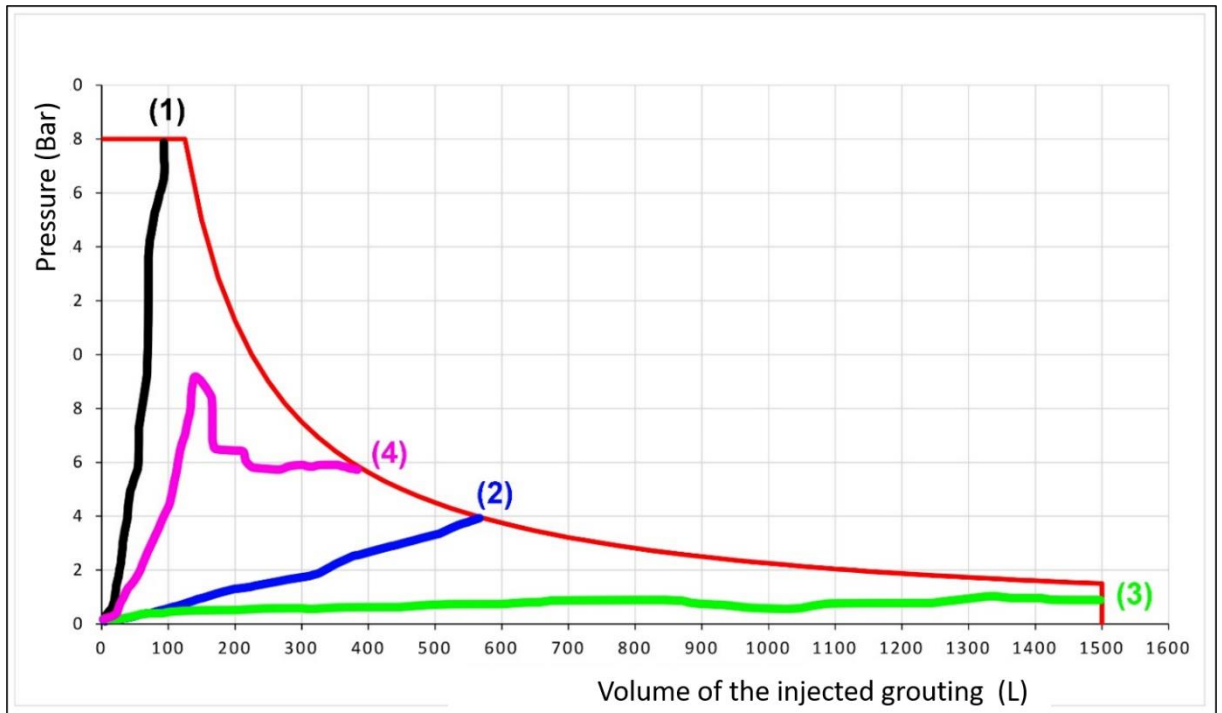
(3) Significant ground absorption at low pressure, indicating that the ground is heavily depressurized (possibility of void or cavity). The injected volume serves as filling and improvement of the ground.

(4) Pressure drop indicating that there has been fracturing (creation of cracks or widening of existing cracks). In this case, the injection flow rate should be kept low and the vicinity of the borehole visually inspected. Pressure may increase again, indicating that the depressurized area is filled with grout. If not, the depressurized area has a volume greater than P_{max} , and it will be consolidated by the surrounding boreholes.

Fig. 4.10. Example of a recommended gin curve with possible indications of ground depressurization status and injection effectiveness.

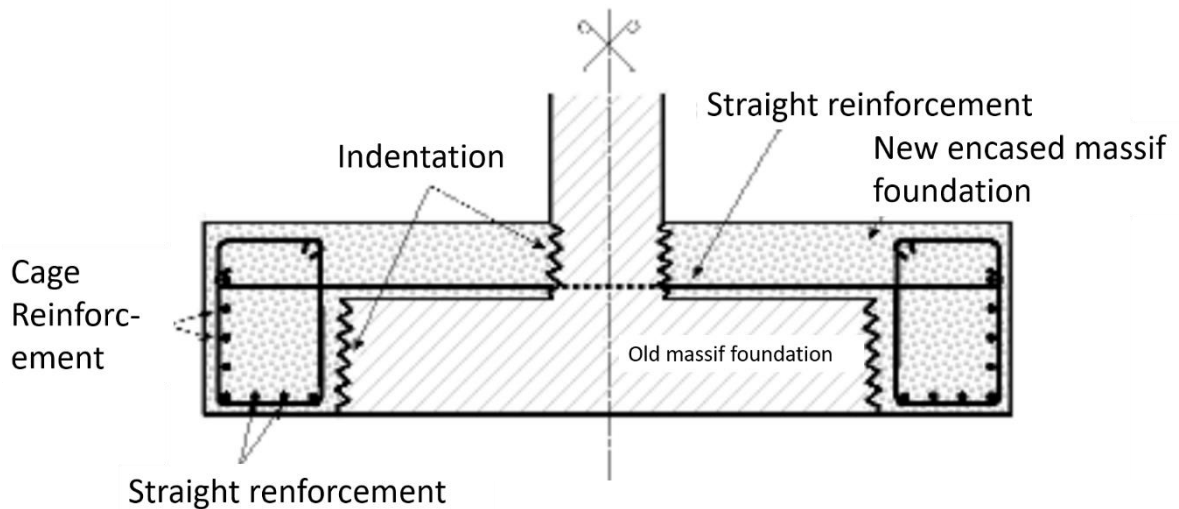
Due to the low probability of collapse sinkholes occurring adjacent to the failed building in the northwestern part of Ouled Djellal city, the use of anti-sinkhole footings or ladder structures is not recommended. Instead, the focus should be on implementing anti-sagging measures to reinforce the failed buildings. These measures will help stabilize the structures and prevent further sagging, ensuring their structural integrity and safety.

Fig. 4.11. Increasing the Surface Area of the Footing with Added Thickness. Objective: Expand the Surface Area to Reduce Soil Stress, Enhance Rigidity, and Strengthen Footing Reinforcement (Adapted from [72]).

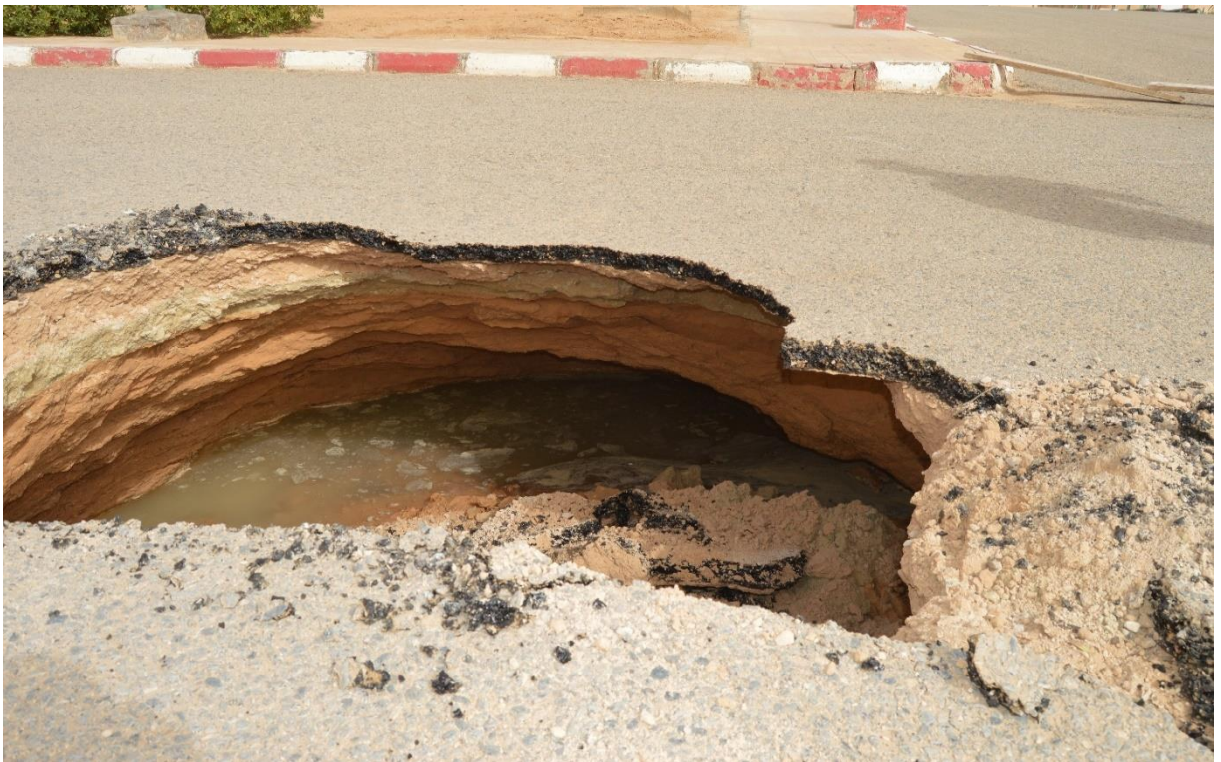
Given the cases of geohazards associated with gypsum dissolution phenomenon reported by local authorities in Touggourt (Fig. 4.12), Oran, Elwadi states, and Tebessa, it's imperative to adopt a national planning strategy in Algeria similar to the geological survey approach in the UK. This strategy would aim to prevent the construction of buildings in high-risk areas prone to gypsum-related geohazards. However, to ensure effectiveness and mitigate potential risks, this national planning should be accompanied by detailed local planning efforts. This dual approach is essential to minimize the impact of gypsum dissolution hazards on infrastructure and communities while avoiding costly and detrimental development in vulnerable regions.

Fig. 4.12. Sinkhole associated to gypsum dissolution process (Touggourt, Algeria, 2018).
