Université Mohamed Khider – Biskra
Faculté des Sciences et de la technologie
Département de Génie Civil et Hydraulique
Réf :

Thèse de Doctorat LMD
Spécialité : GENIE CIVIL
Option : MATERIAUX DE CONSTRUCTION

Etude de la pathologie des fissurations de bâtiment suite au phénomène de dissolution du gypse cas des bâtiments de Ouled Djellal.

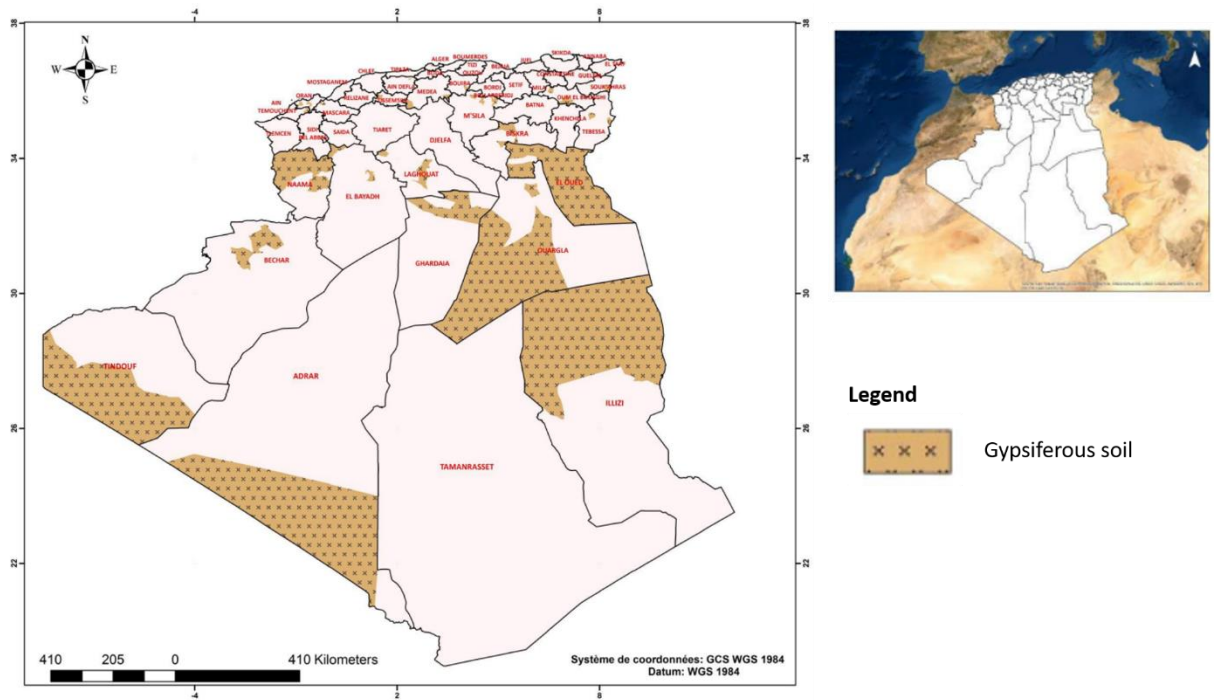
In the same context, an interior planning policy is already in place, backed by the National Organization for Technical Control of Construction in Algeria. However, this policy was insufficient as it did not consider either the type (subsidence/sinkholes) or the intensity of the geohazard (Fig. 4.13).

Fig. 4.13. Geotechnical Hazards on a National Scale (CTC Database - Phase I): Map of Gypsiferous Soils, 2021.

- The consideration of either the type (subsidence/sinkholes) or the intensity of the geohazard in a national plan, supplemented by a local one, offers a predefined categorized map. These categories should be comparable to the three categories A, B, and C mentioned previously in the literature review in Ripon, UK, where:
- Category A represents regions with known gypsum.
- Category B includes areas where some gypsum is present at depth.
- Category C covers regions where gypsum is present and susceptible to dissolution.
